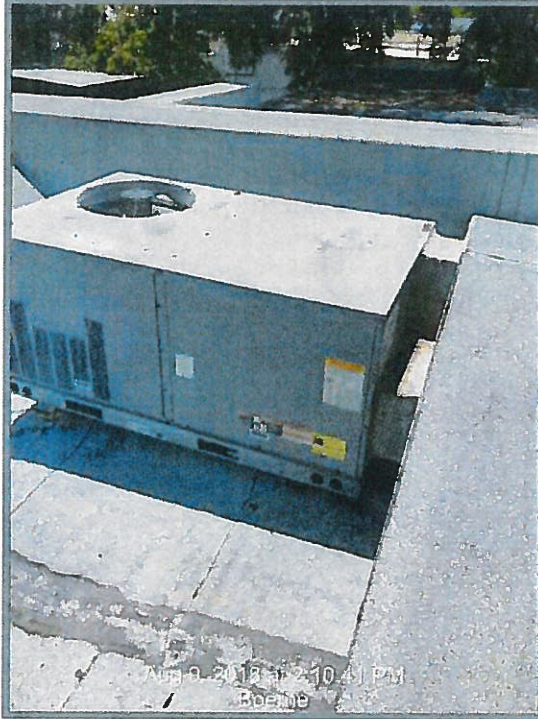
Photograph #35

Overview of rear HVAC system. Visible repairs to this area.

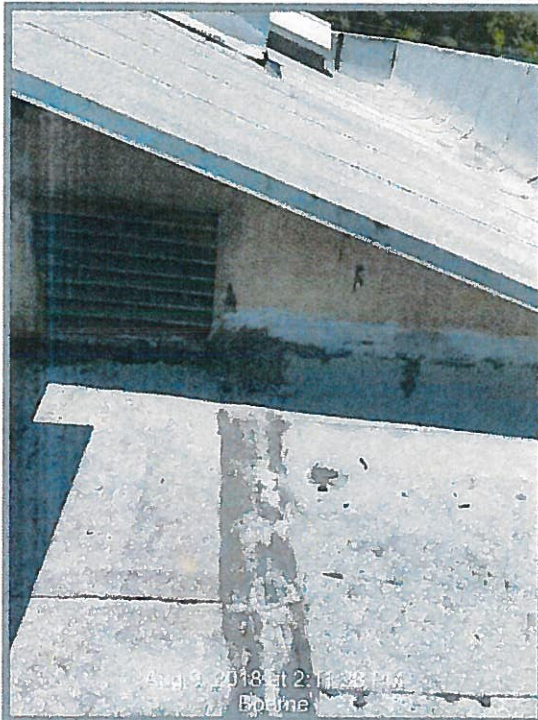
Photograph #36

Rear elevation - tar patches along the building with roofing material.

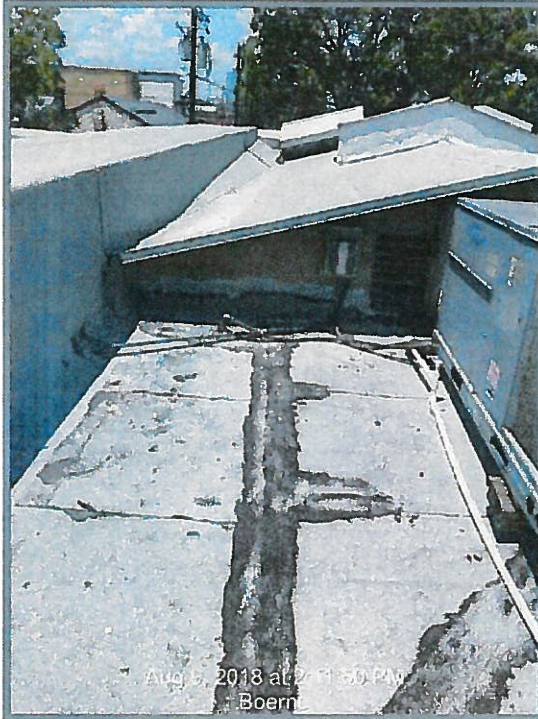
Photograph #37

Rear elevation - several tar patches and abnormal wear to the roofing material.

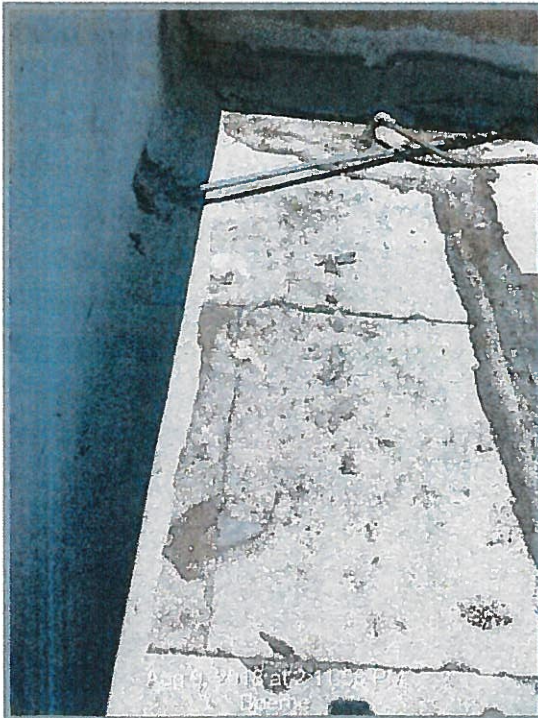
Photograph #38

Overview of rear elevation near the HVAC unit.

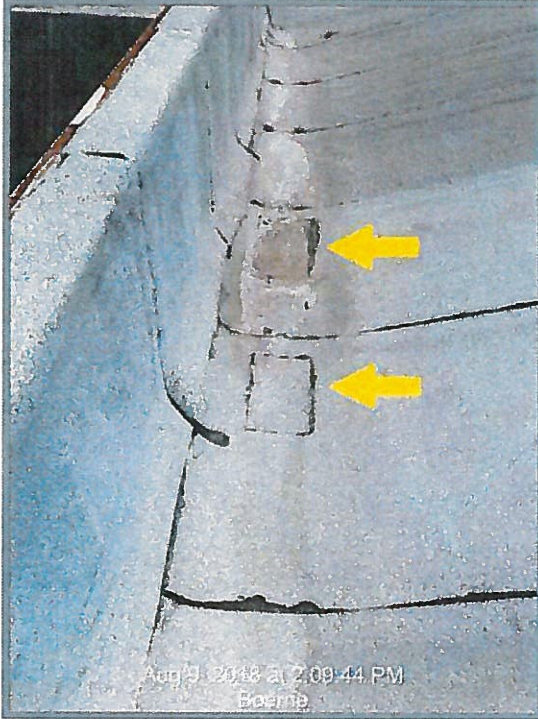
Photograph #31

Left elevation - Parapet wall overview with two visible repairs.

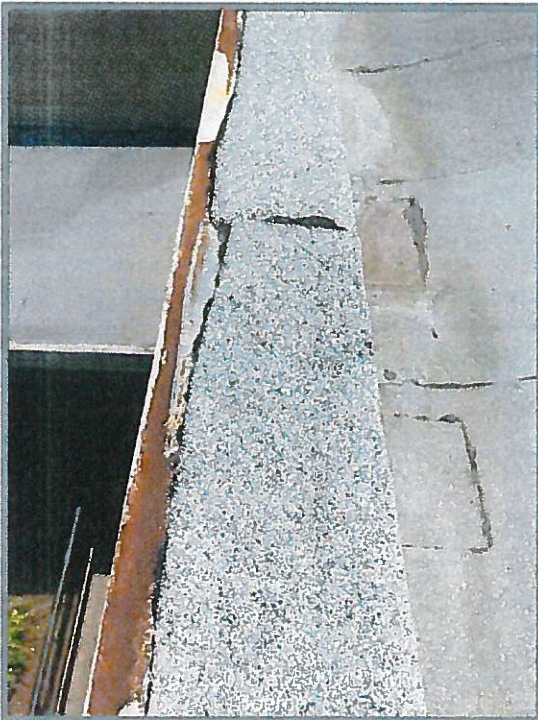
Photograph #32

Parapet wall over the window with water damages. Visible fibers of roofing material. This is not storm related.

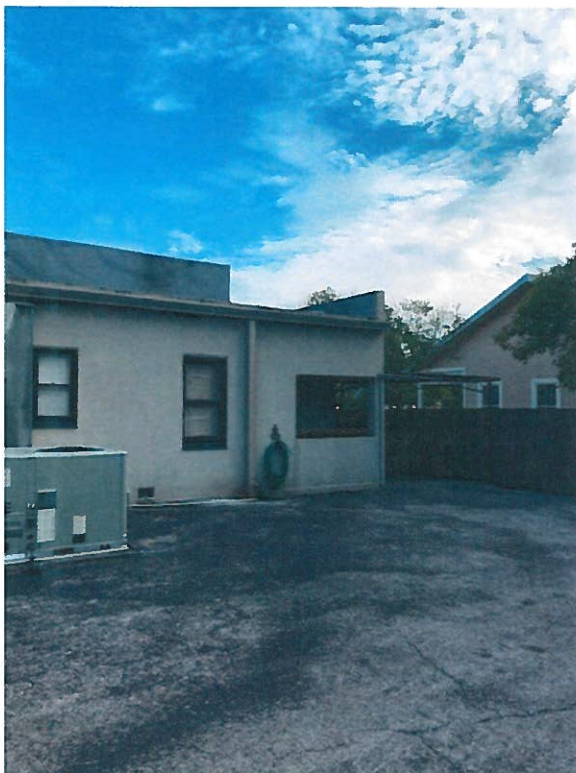
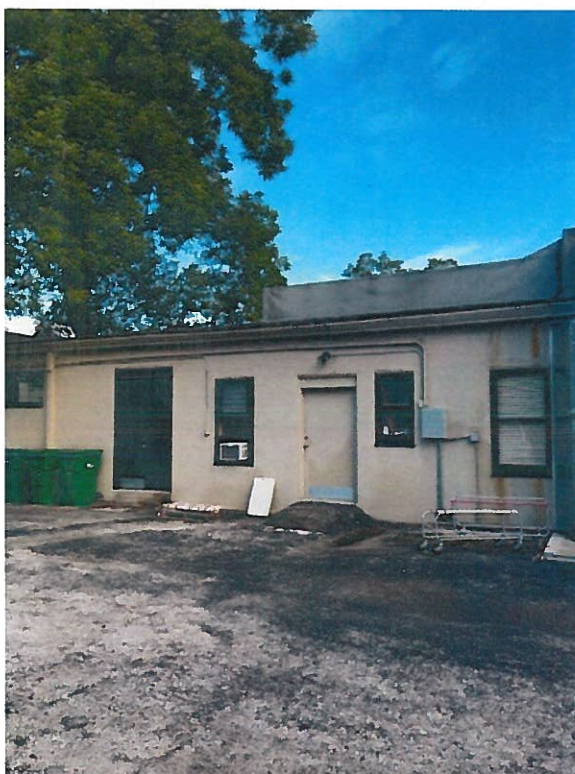
Gutter Replacement at rear of bldg.
