# 179 S. Main

2016.09.23 HISTORICAL REVIEW SUBMISSION

**ZIEGLER BUILDING DEVELOPMENT**  
COLORADO RIVER PROPERTIES, LLC.  
Boerne, Texas

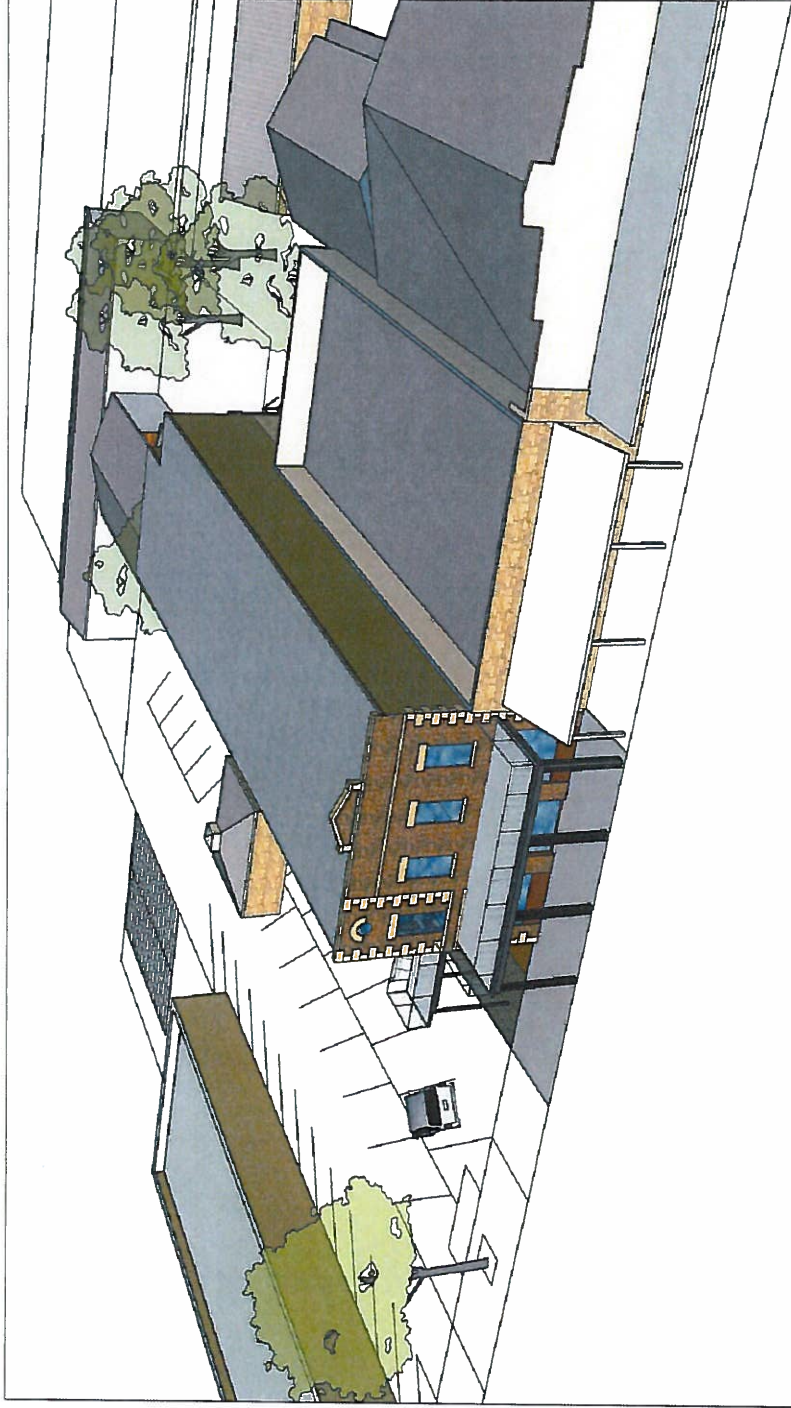
NORTHWEST VIEW OFF MAIN STREET

## NEW CONSTRUCTION

1. EXISTING WOOD WINDOW ASSEMBLY /  
REPLACE ALL DAMAGED GLASS PANELS /  
RECAULK ALL JOINTS / PAINT ALL WOOD  
FRAMES COMPLETE
2. EXISTING LIMESTONE TO REMAIN /  
PRESSURE WASH ALL EXPOSED SURFACES

3. EXISTING BRICK VENEER TO REMAIN /  
PRESSURE WASH ALL EXPOSED SURFACES
4. EXISTING DOOR ASSEMBLY TO REMAIN /  
PAINT ALL EXPOSED SURFACES
5. EXISTING WOOD WINDOW ASSEMBLY /  
REPLACE ALL DAMAGED GLASS PANELS /  
RECAULK ALL JOINTS / PAINT ALL WOOD  
FRAMES COMPLETE

6. EXISTING LIMESTONE TO REMAIN /  
PRESSURE WASH ALL EXPOSED SURFACES
7. EXISTING BRICK VENEER TO REMAIN /  
PRESSURE WASH ALL EXPOSED SURFACES
8. EXISTING DOOR ASSEMBLY TO REMAIN /  
PAINT ALL EXPOSED SURFACES

9. STANDING SEAM METAL  
ROOFING SYSTEM / PRE-FINISHED
10. CORRUGATED "S" DECK METAL  
WALL PANEL (BARN TIN) /  
GALVANIZED FINISH
11. WOOD FASCIA TRIM / PAINT

12. STAIR AND LANDING ASSEMBLY /  
CONCRETE TREADS AND LANDINGS -  
FLAMED FINISH / 6" X 6" STEEL POST WITH  
COLLARS / EXPOSED TUBE STEEL BEAMS  
/ ALL STEEL SHALL BE PAINTED

13. GUARDRAIL / HANDRAIL ASSEMBLY /  
1" X 1 1/2" 14 GAUGE TOP RAIL / 1/2" X 1/2"  
16 GAUGE VERTICAL PICKETS AT 4" O.C. WITH  
1 1/2" X 1 1/2" 11 GAUGE HORIZONTAL RAIL /  
ALL STEEL SHALL BE PAINTED
