2016.09.23| HISTORICAL REVIEW SUBMISSION

ZIEGLER BUILDING DEVELOPMENT
COLORADO RIVER PROPERTIES, LLC.
Boerne, Texas

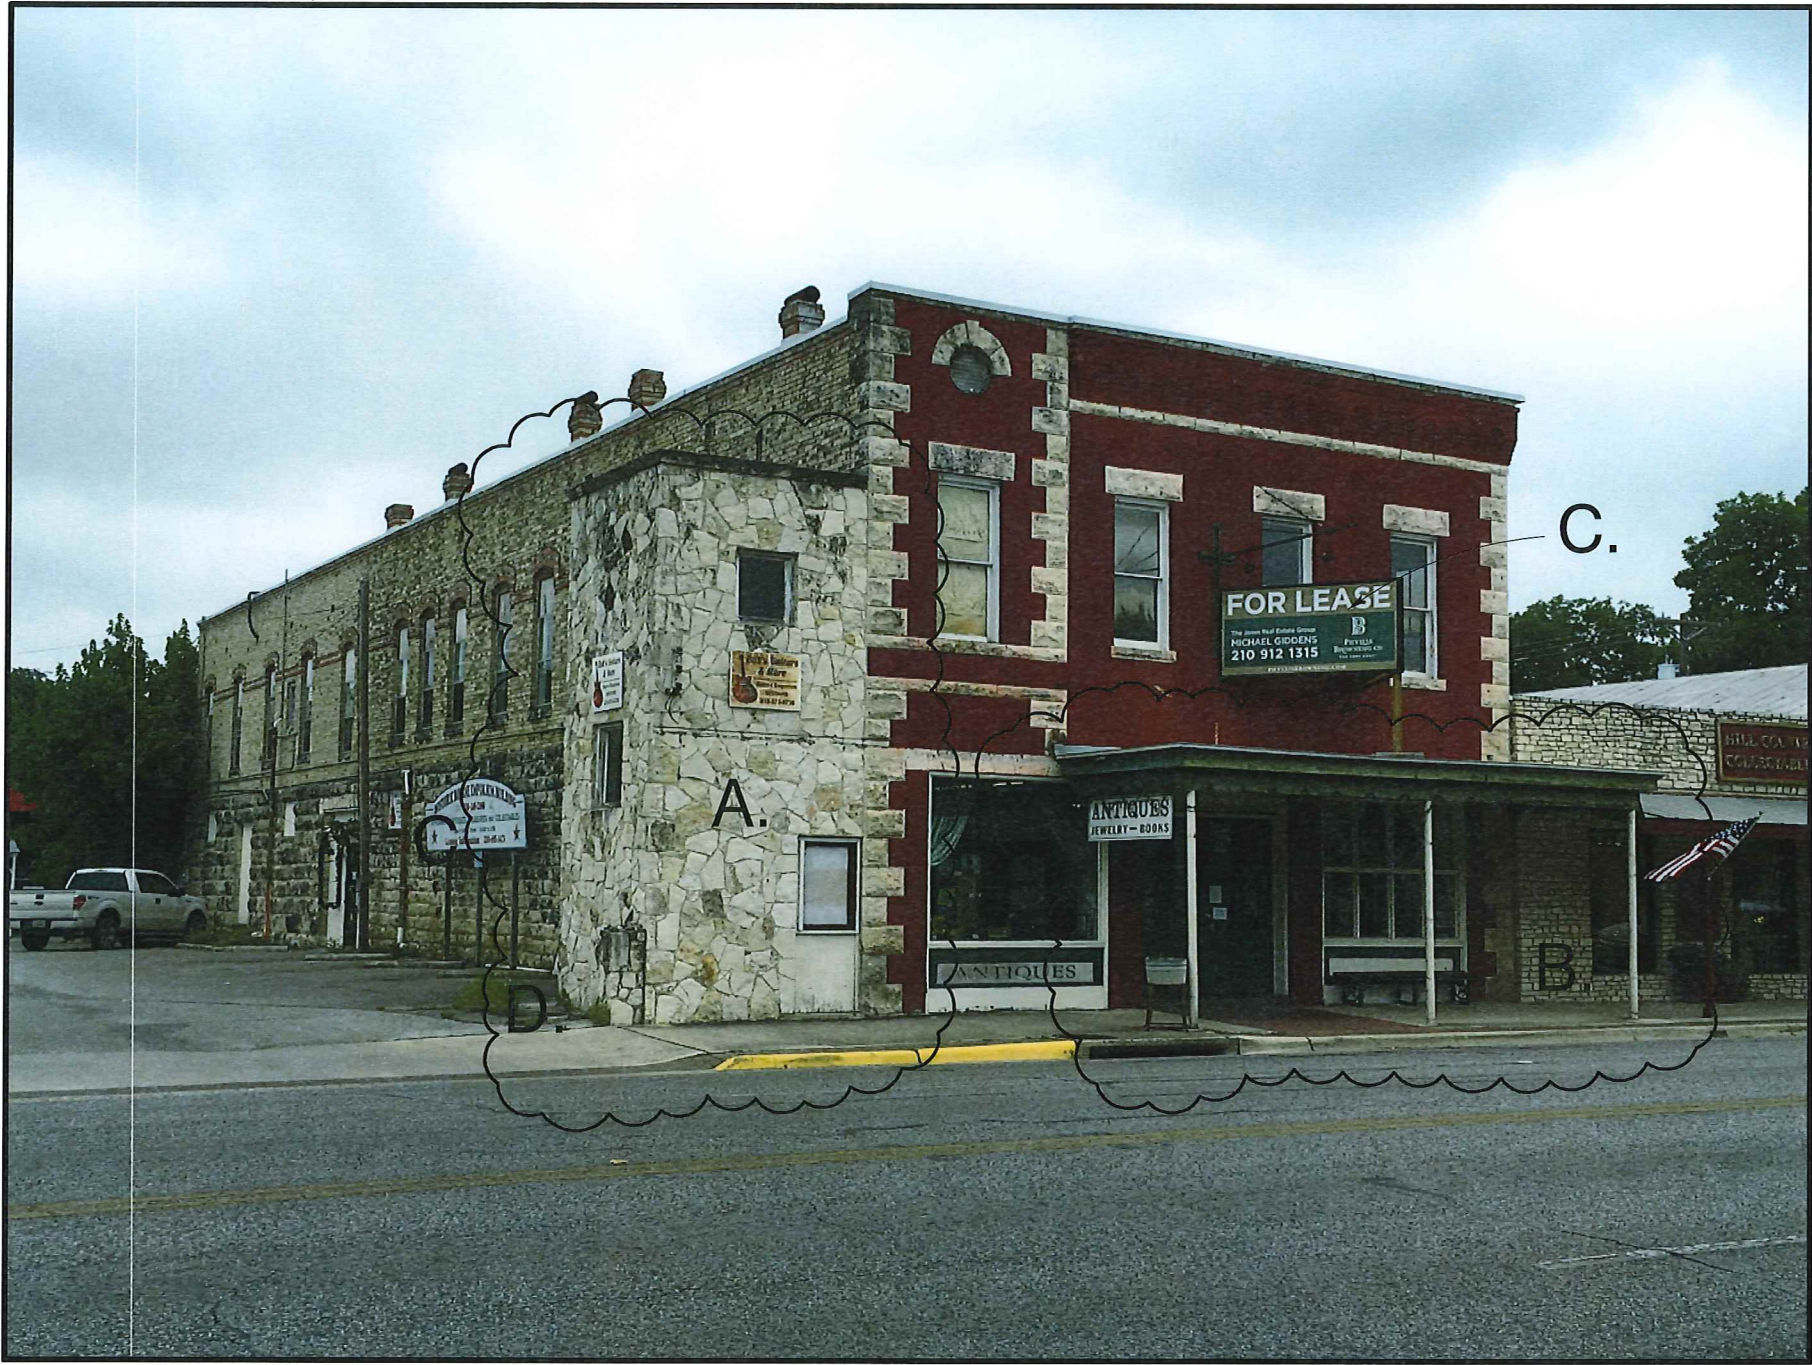
EXISTING IMAGE- NORTH WEST CORNER

- A. REMOVE EXISTING TOWER COMPLETE
- B. REMOVE EXISTING CANOPY COMPLETE
- C. REMOVE EXISTING SIGNAGE COMPLETE
- D. REMOVE EXISTING ASPHALT PAVING COMPLETE WHERE NEW CONSTRUCTION OCCURS
- E. REMOVE EXISTING STAIRWAY COMPLETE / COORDINATE WITH NEW CONSTRUCTION OCCURS

- 1. EXISTING WOOD WINDOW ASSEMBLY / REPLACE ALL DAMAGED GLASS PANELS / RECAULK ALL JOINTS / PAINT ALL WOOD FRAMES COMPLETE
- 2. EXISTING LIMESTONE TO REMAIN / PRESSURE WASH ALL EXPOSED SURFACES
- 3. EXISTING BRICK VENEER TO REMAIN / PRESSURE WASH ALL EXPOSED SURFACES
- 4. EXISTING DOOR ASSEMBLY TO REMAIN / PAINT ALL EXPOSED SURFACES
- 5. EXISTING WOOD WINDOW ASSEMBLY / REPLACE ALL DAMAGED GLASS PANELS / RECAULK ALL JOINTS / PAINT ALL WOOD FRAMES COMPLETE
- 6. EXISTING LIMESTONE TO REMIAN / PRESSURE WASH ALL EXPOSED SURFACES
- 7. EXISTING BRICK VENEER TO REMAIN . PRESSURE WASH ALL EXPOSED SURFACES
- 8. EXISTING DOOR ASSEMBLY TO REMAIN / PAINT ALL EXPOSED SURFACES

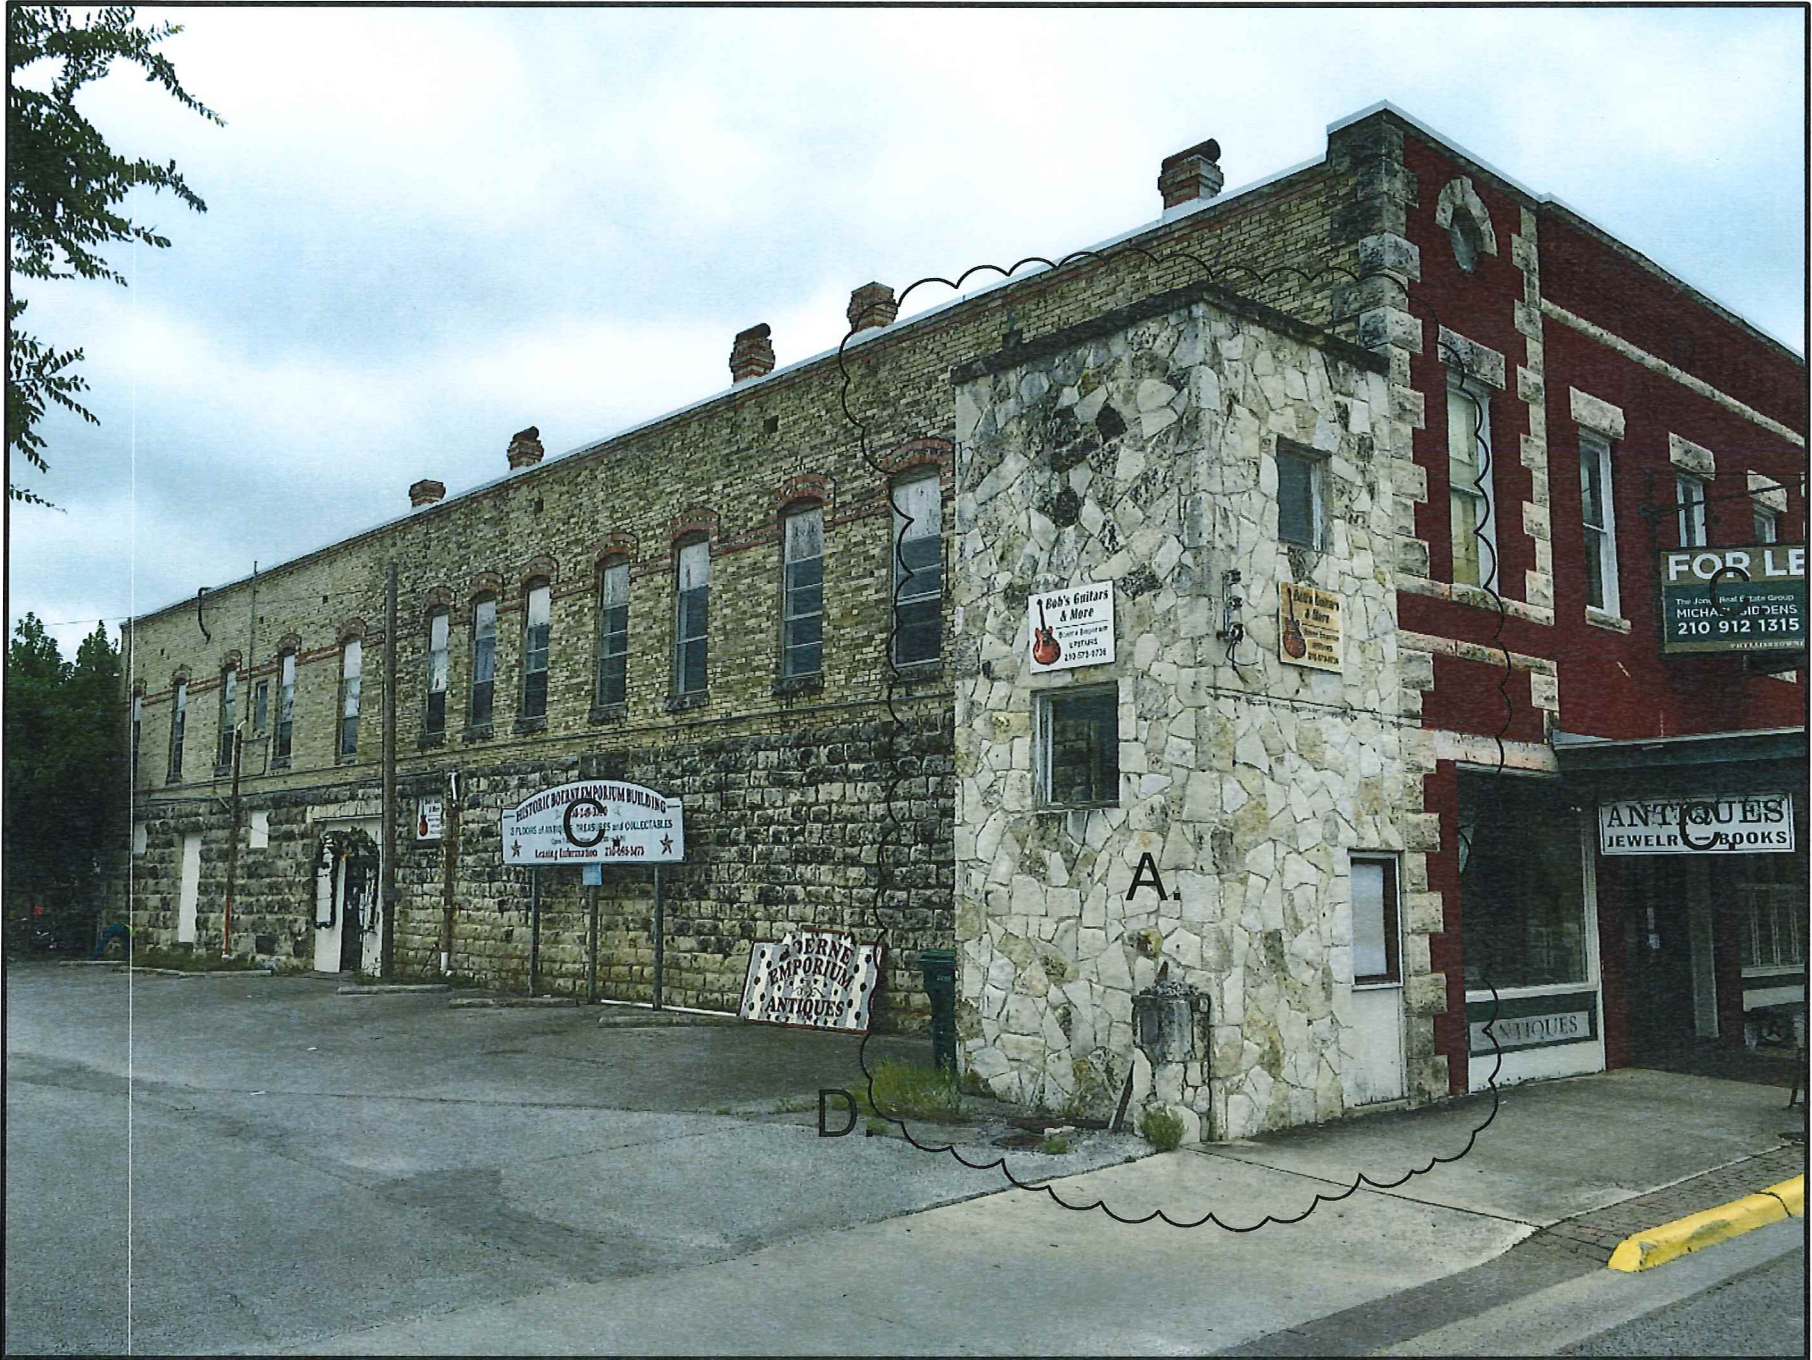
EXISTING IMAGE- NORTH WEST CORNER

- A. REMOVE EXISTING TOWER COMPLETE
- B. REMOVE EXISTING CANOPY COMPLETE
- C. REMOVE EXISTING SIGNAGE COMPLETE
- D. REMOVE EXISTING ASPHALT PAVING COMPLETE WHERE NEW CONSTRUCTION OCCURS
- E. REMOVE EXISTING STAIRWAY COMPLETE / COORDINATE WITH NEW CONSTRUCTION OCCURS

- 1. EXISTING WOOD WINDOW ASSEMBLY / REPLACE ALL DAMAGED GLASS PANELS / RECAULK ALL JOINTS / PAINT ALL WOOD FRAMES COMPLETE
- 2. EXISTING LIMESTONE TO REMAIN / PRESSURE WASH ALL EXPOSED SURFACES
- 3. EXISTING BRICK VENEER TO REMAIN / PRESSURE WASH ALL EXPOSED SURFACES
- 4. EXISTING DOOR ASSEMBLY TO REMAIN / PAINT ALL EXPOSED SURFACES
- 5. EXISTING WOOD WINDOW ASSEMBLY / REPLACE ALL DAMAGED GLASS PANELS / RECAULK ALL JOINTS / PAINT ALL WOOD FRAMES COMPLETE
- 6. EXISTING LIMESTONE TO REMIAN / PRESSURE WASH ALL EXPOSED SURFACES
- 7. EXISTING BRICK VENEER TO REMAIN . PRESSURE WASH ALL EXPOSED SURFACES
- 8. EXISTING DOOR ASSEMBLY TO REMAIN / PAINT ALL EXPOSED SURFACES

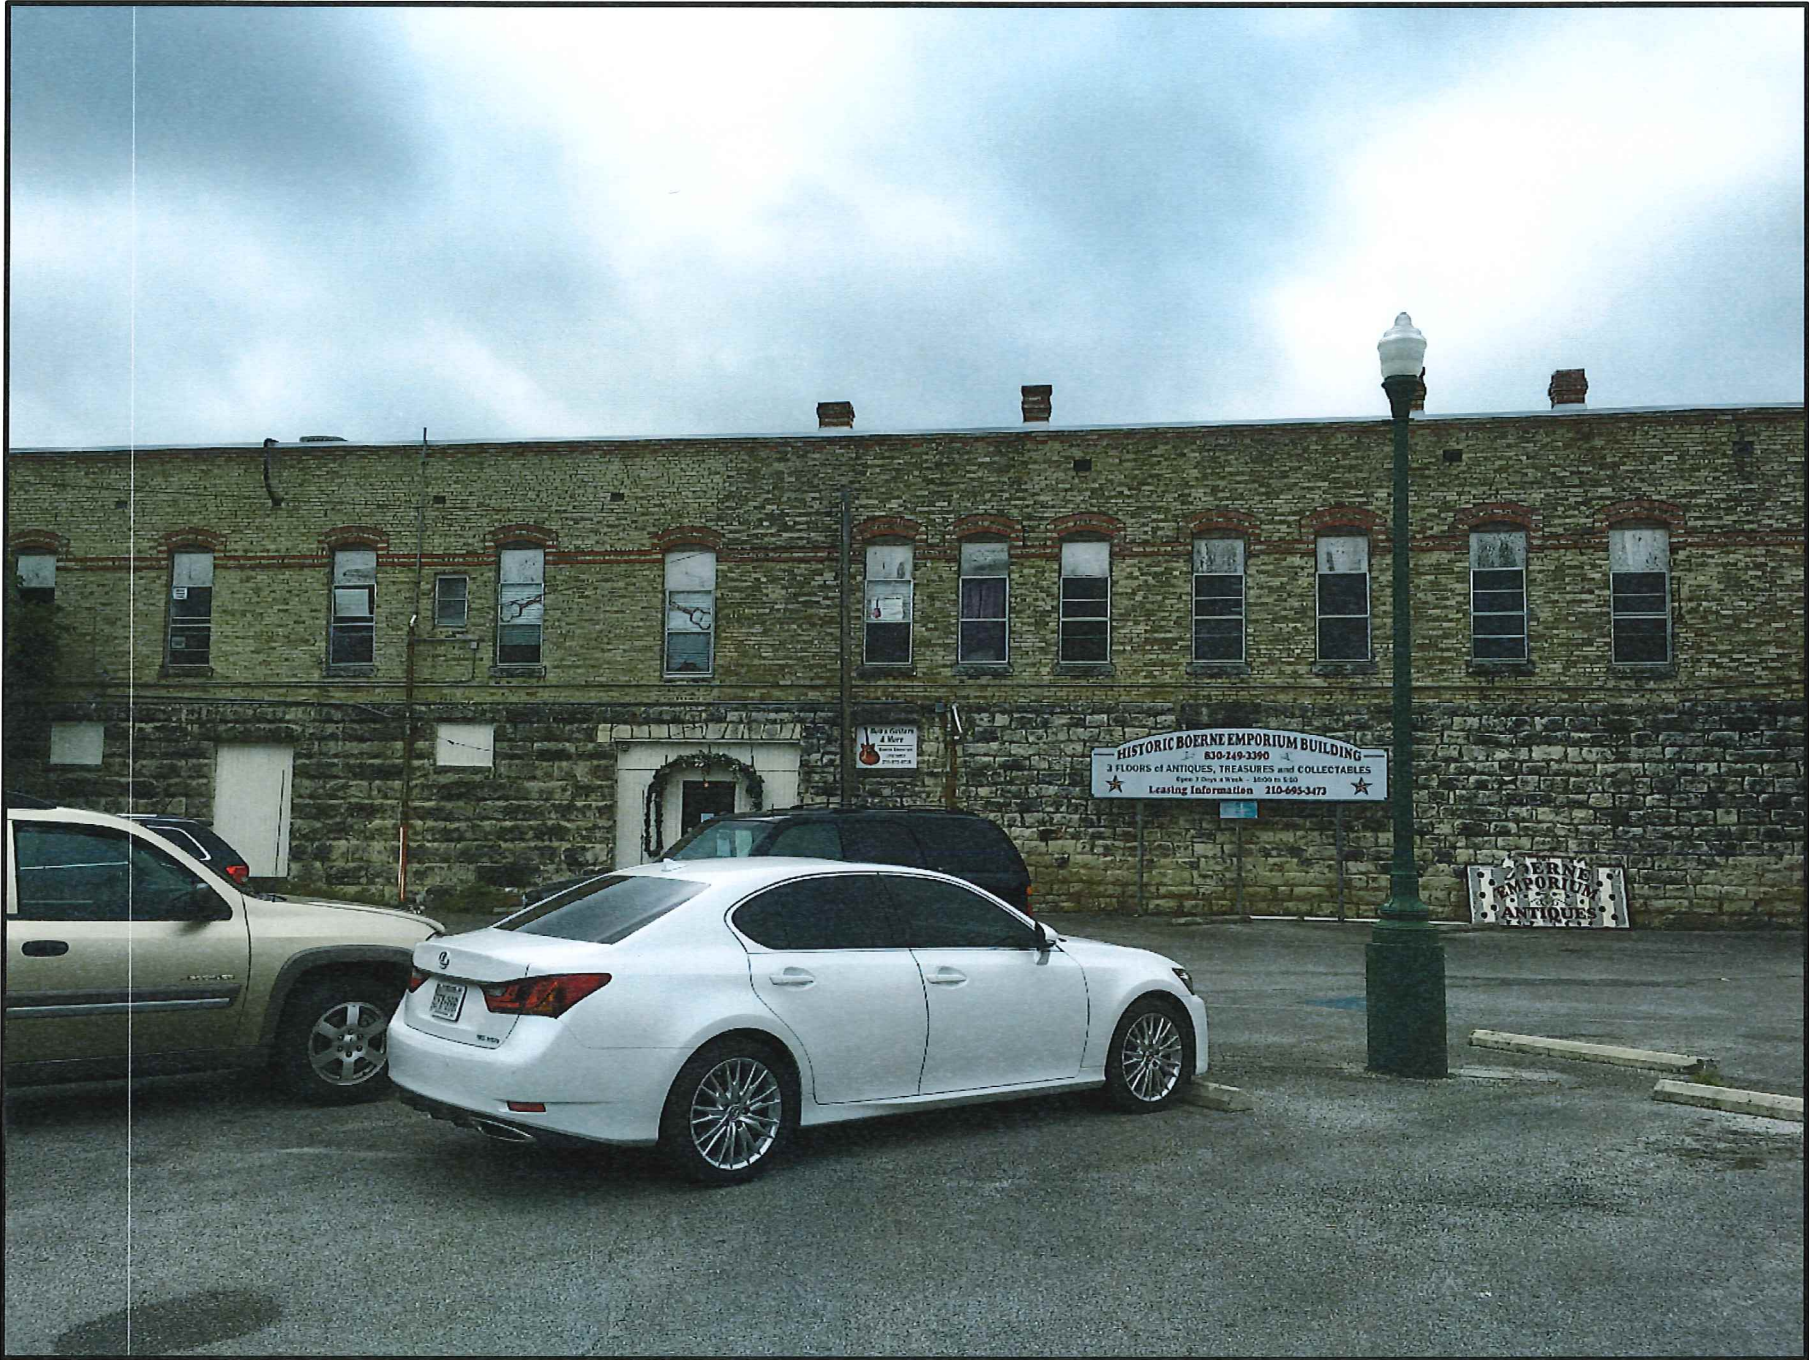
EXISTING IMAGE- NORTH ELEVATION

- A. REMOVE EXISTING TOWER COMPLETE
- B. REMOVE EXISTING CANOPY COMPLETE
- C. REMOVE EXISTING SIGNAGE COMPLETE
- D. REMOVE EXISTING ASPHALT PAVING COMPLETE WHERE NEW CONSTRUCTION OCCURS
- E. REMOVE EXISTING STAIRWAY COMPLETE / COORDINATE WITH NEW CONSTRUCTION OCCURS

- 1. EXISTING WOOD WINDOW ASSEMBLY / REPLACE ALL DAMAGED GLASS PANELS / RECAULK ALL JOINTS / PAINT ALL WOOD FRAMES COMPLETE
- 2. EXISTING LIMESTONE TO REMAIN / PRESSURE WASH ALL EXPOSED SURFACES
- 3. EXISTING BRICK VENEER TO REMAIN / PRESSURE WASH ALL EXPOSED SURFACES
- 4. EXISTING DOOR ASSEMBLY TO REMAIN / PAINT ALL EXPOSED SURFACES
- 5. EXISTING WOOD WINDOW ASSEMBLY / REPLACE ALL DAMAGED GLASS PANELS / RECAULK ALL JOINTS / PAINT ALL WOOD FRAMES COMPLETE
- 6. EXISTING LIMESTONE TO REMIAN / PRESSURE WASH ALL EXPOSED SURFACES
- 7. EXISTING BRICK VENEER TO REMAIN . PRESSURE WASH ALL EXPOSED SURFACES
- 8. EXISTING DOOR ASSEMBLY TO REMAIN / PAINT ALL EXPOSED SURFACES

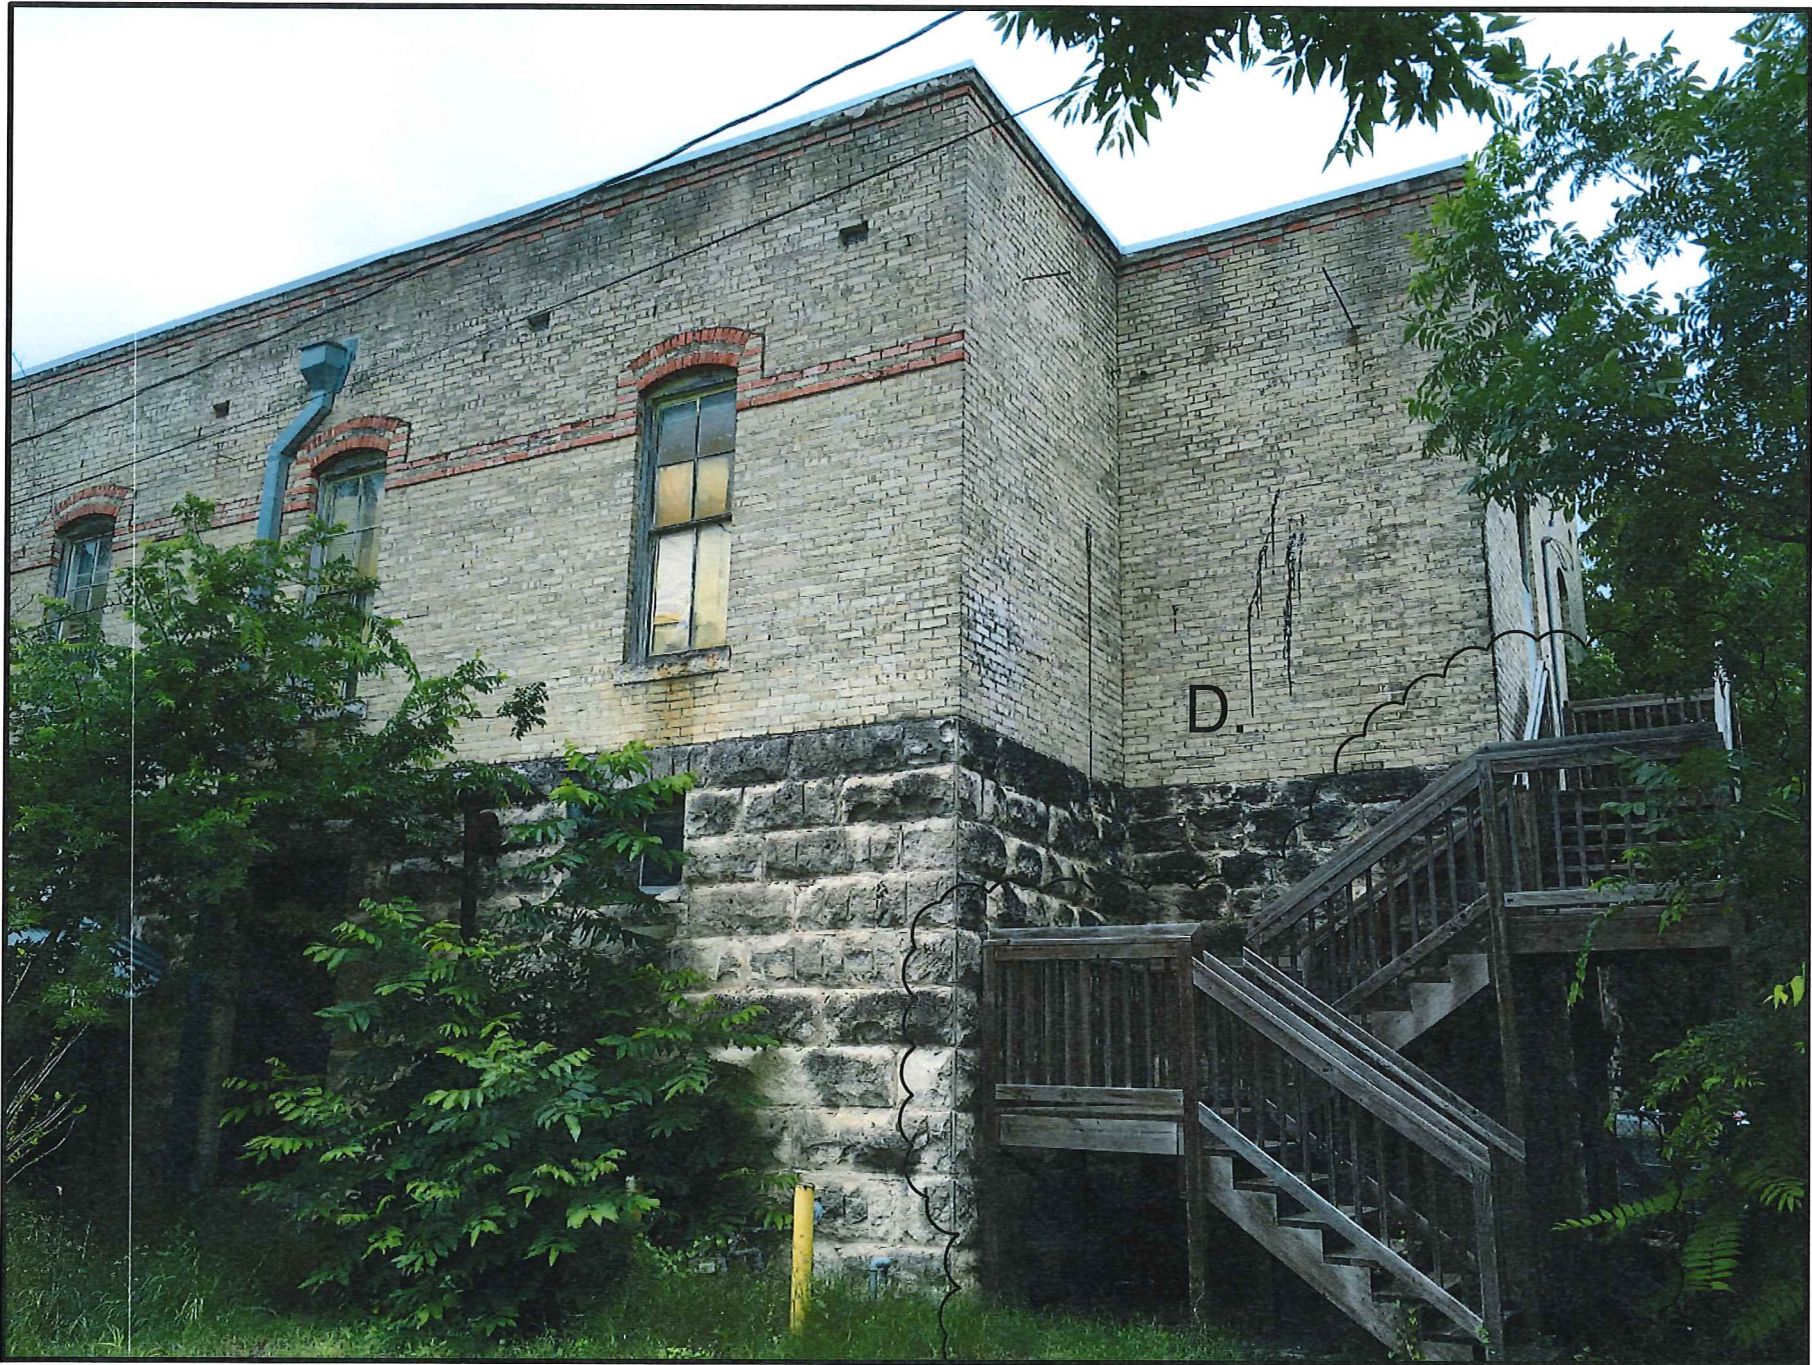
EXISTING IMAGE- SOUTH EAST CORNER

- A. REMOVE EXISTING TOWER
COMPLETE
- B. REMOVE EXISTING CANOPY
COMPLETE
- C. REMOVE EXISTING SIGNAGE
COMPLETE
- D. REMOVE EXISTING ASPHALT
PAVING COMPLETE WHERE
NEW CONSTRUCTION OCCURS
- E. REMOVE EXISTING STAIRWAY
COMPLETE / COORDINATE WITH
NEW CONSTRUCTION OCCURS

- 1. EXISTING WOOD WINDOW ASSEMBLY /
REPLACE ALL DAMAGED GLASS PANELS /
RECAULK ALL JOINTS / PAINT ALL WOOD
FRAMES COMPLETE
- 2. EXISTING LIMESTONE TO REMAIN /
PRESSURE WASH ALL EXPOSED SURFACES
- 3. EXISTING BRICK VENEER TO REMAIN /
PRESSURE WASH ALL EXPOSED SURFACES
- 4. EXISTING DOOR ASSEMBLY TO REMAIN /
PAINT ALL EXPOSED SURFACES
- 5. EXISTING WOOD WINDOW ASSEMBLY /
REPLACE ALL DAMAGED GLASS PANELS /
RECAULK ALL JOINTS / PAINT ALL WOOD
FRAMES COMPLETE
- 6. EXISTING LIMESTONE TO REMIAN /
PRESSURE WASH ALL EXPOSED SURFACES
- 7. EXISTING BRICK VENEER TO REMAIN .
PRESSURE WASH ALL EXPOSED SURFACES
- 8. EXISTING DOOR ASSEMBLY TO REMAIN /
PAINT ALL EXPOSED SURFACES

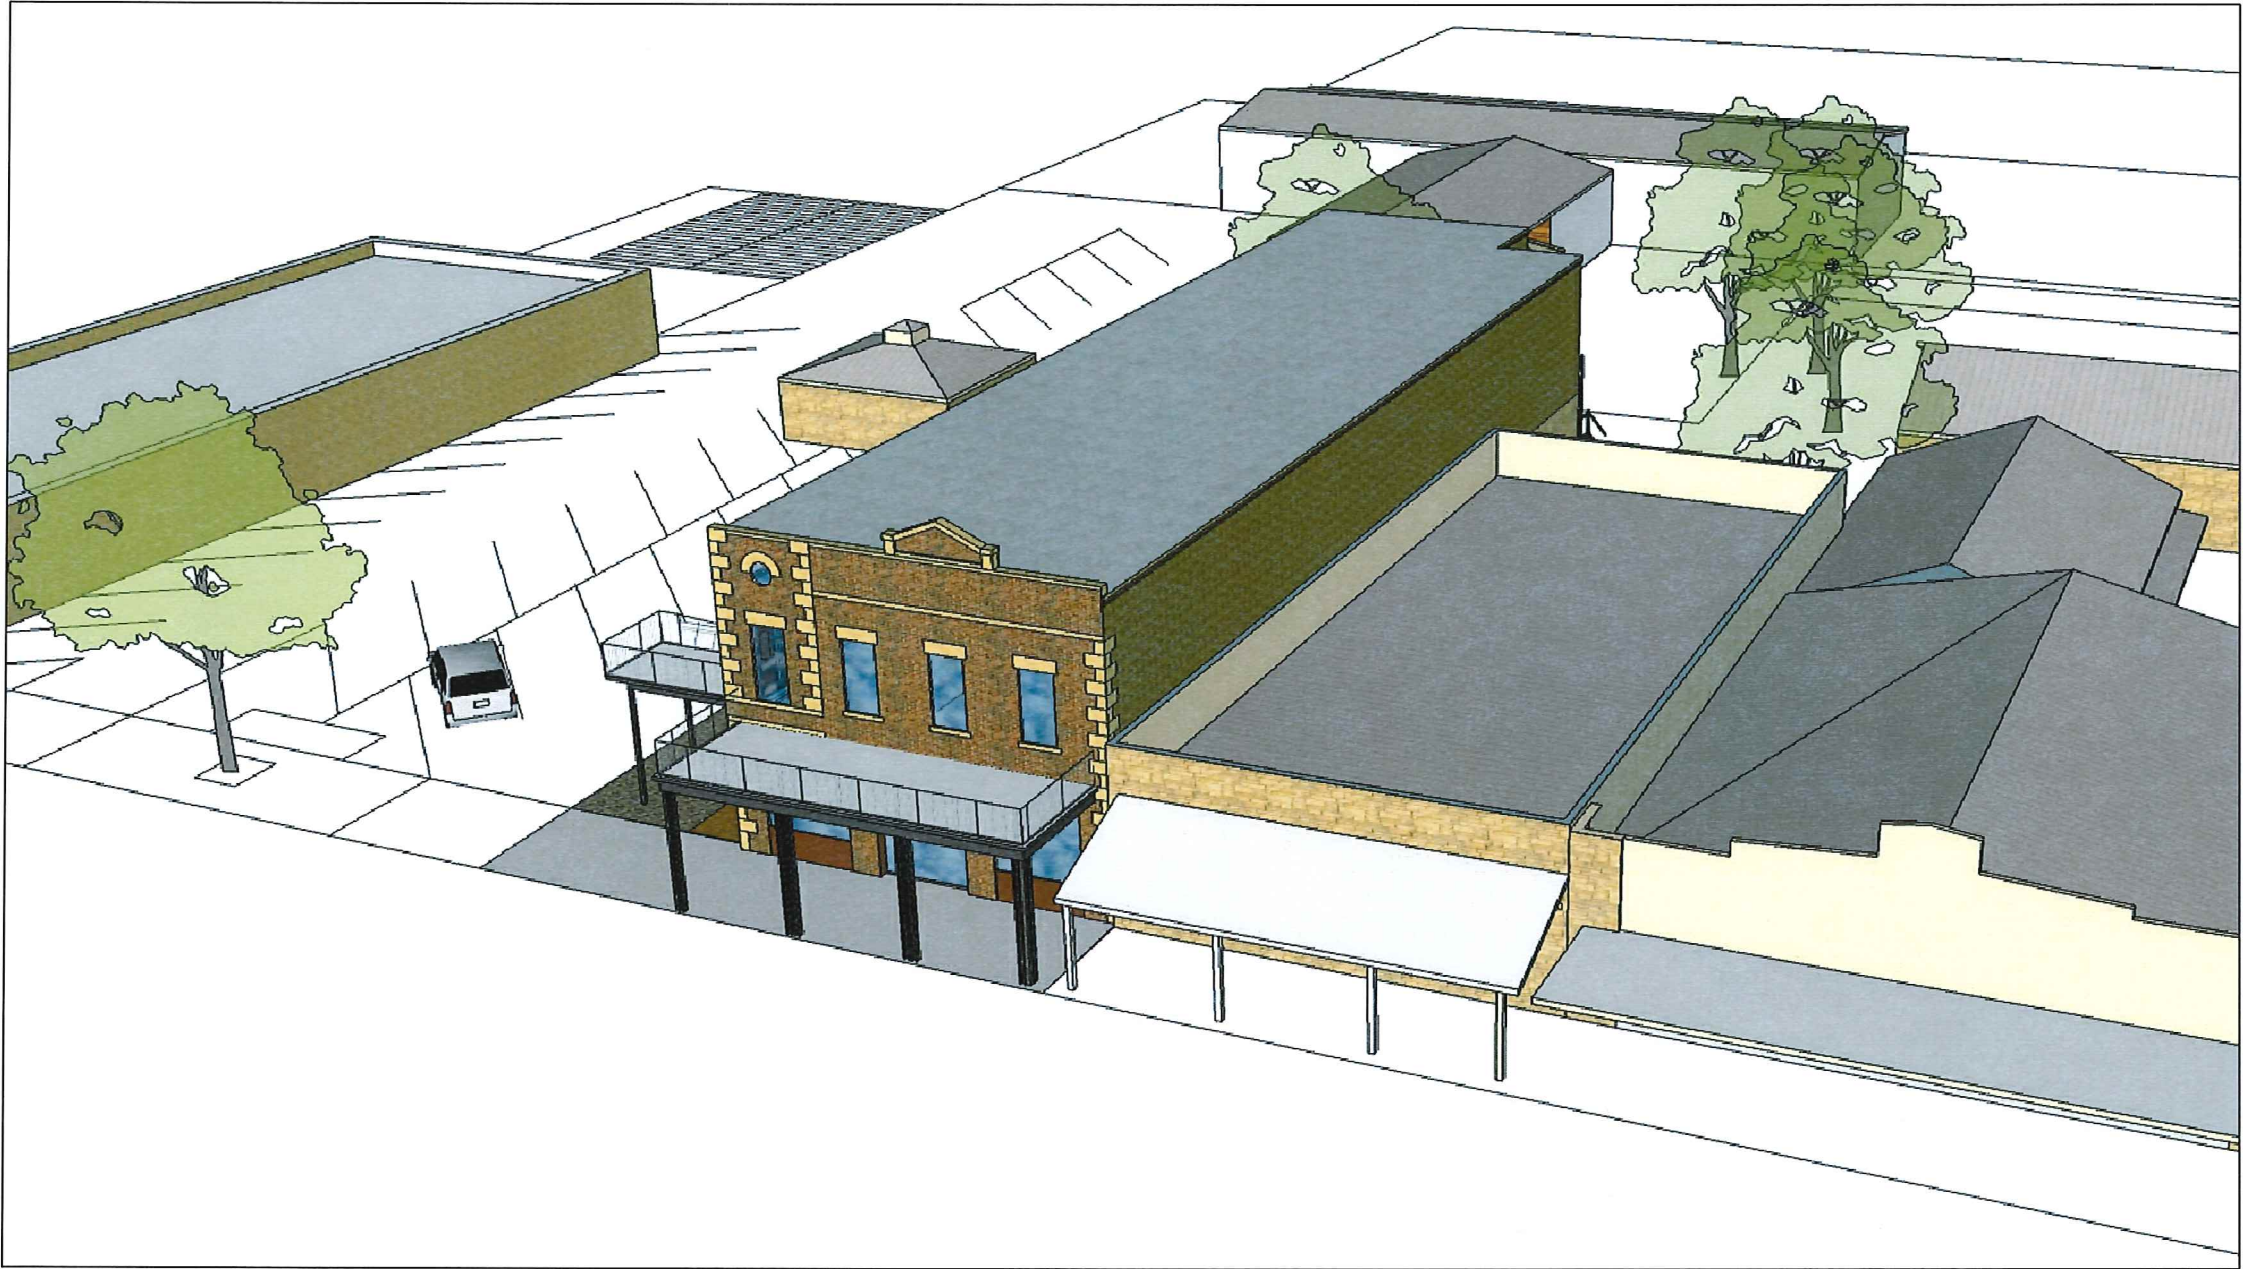
NORTHWEST VIEW OFF MAIN STREET

1. EXISTING WOOD WINDOW ASSEMBLY / REPLACE ALL DAMAGED GLASS PANELS / RECAULK ALL JOINTS / PAINT ALL WOOD FRAMES COMPLETE
2. EXISTING LIMESTONE TO REMAIN / PRESSURE WASH ALL EXPOSED SURFACES

3. EXISTING BRICK VENEER TO REMAIN / PRESSURE WASH ALL EXPOSED SURFACES
4. EXISTING DOOR ASSEMBLY TO REMAIN / PAINT ALL EXPOSED SURFACES
5. EXISTING WOOD WINDOW ASSEMBLY / REPLACE ALL DAMAGED GLASS PANELS / RECAULK ALL JOINTS / PAINT ALL WOOD FRAMES COMPLETE

6. EXISTING LIMESTONE TO REMIAN / PRESSURE WASH ALL EXPOSED SURFACES
7. EXISTING BRICK VENEER TO REMAIN . PRESSURE WASH ALL EXPOSED SURFACES
8. EXISTING DOOR ASSEMBLY TO REMAIN / PAINT ALL EXPOSED SURFACES

9. STANDING SEAM METAL ROOFING SYSTEM / PRE-FINISHED
10. CORRIGATED "S" DECK METAL WALL PANEL (BARN TIN) / GALVANIZED FINISH
11. WOOD FASCIA TRIM / PAINT

12. STAIR AND LANDING ASSEMBLY / CONCRETE TREADS AND LANDINGS - FLAMED FINISH / 6" X 6" STEEL POST WITH COLLARS / EXPOSED TUBE STEEL BEAMS / ALL STEEL SHALL BE PAINTED

13. GUARDRAIL / HANDRAIL ASSEMBLY / 1" X 1 1/2" 14 GAUGE TOP RAIL / 1/2" X 1/2" 16 GAUGE VERTICAL PICKETS AT 4" O.C. WITH 1 1/2" X 1 1/2" 11 GAUGE HORIZONTAL RAIL / ALL STEEL SHALL BE PAINTED

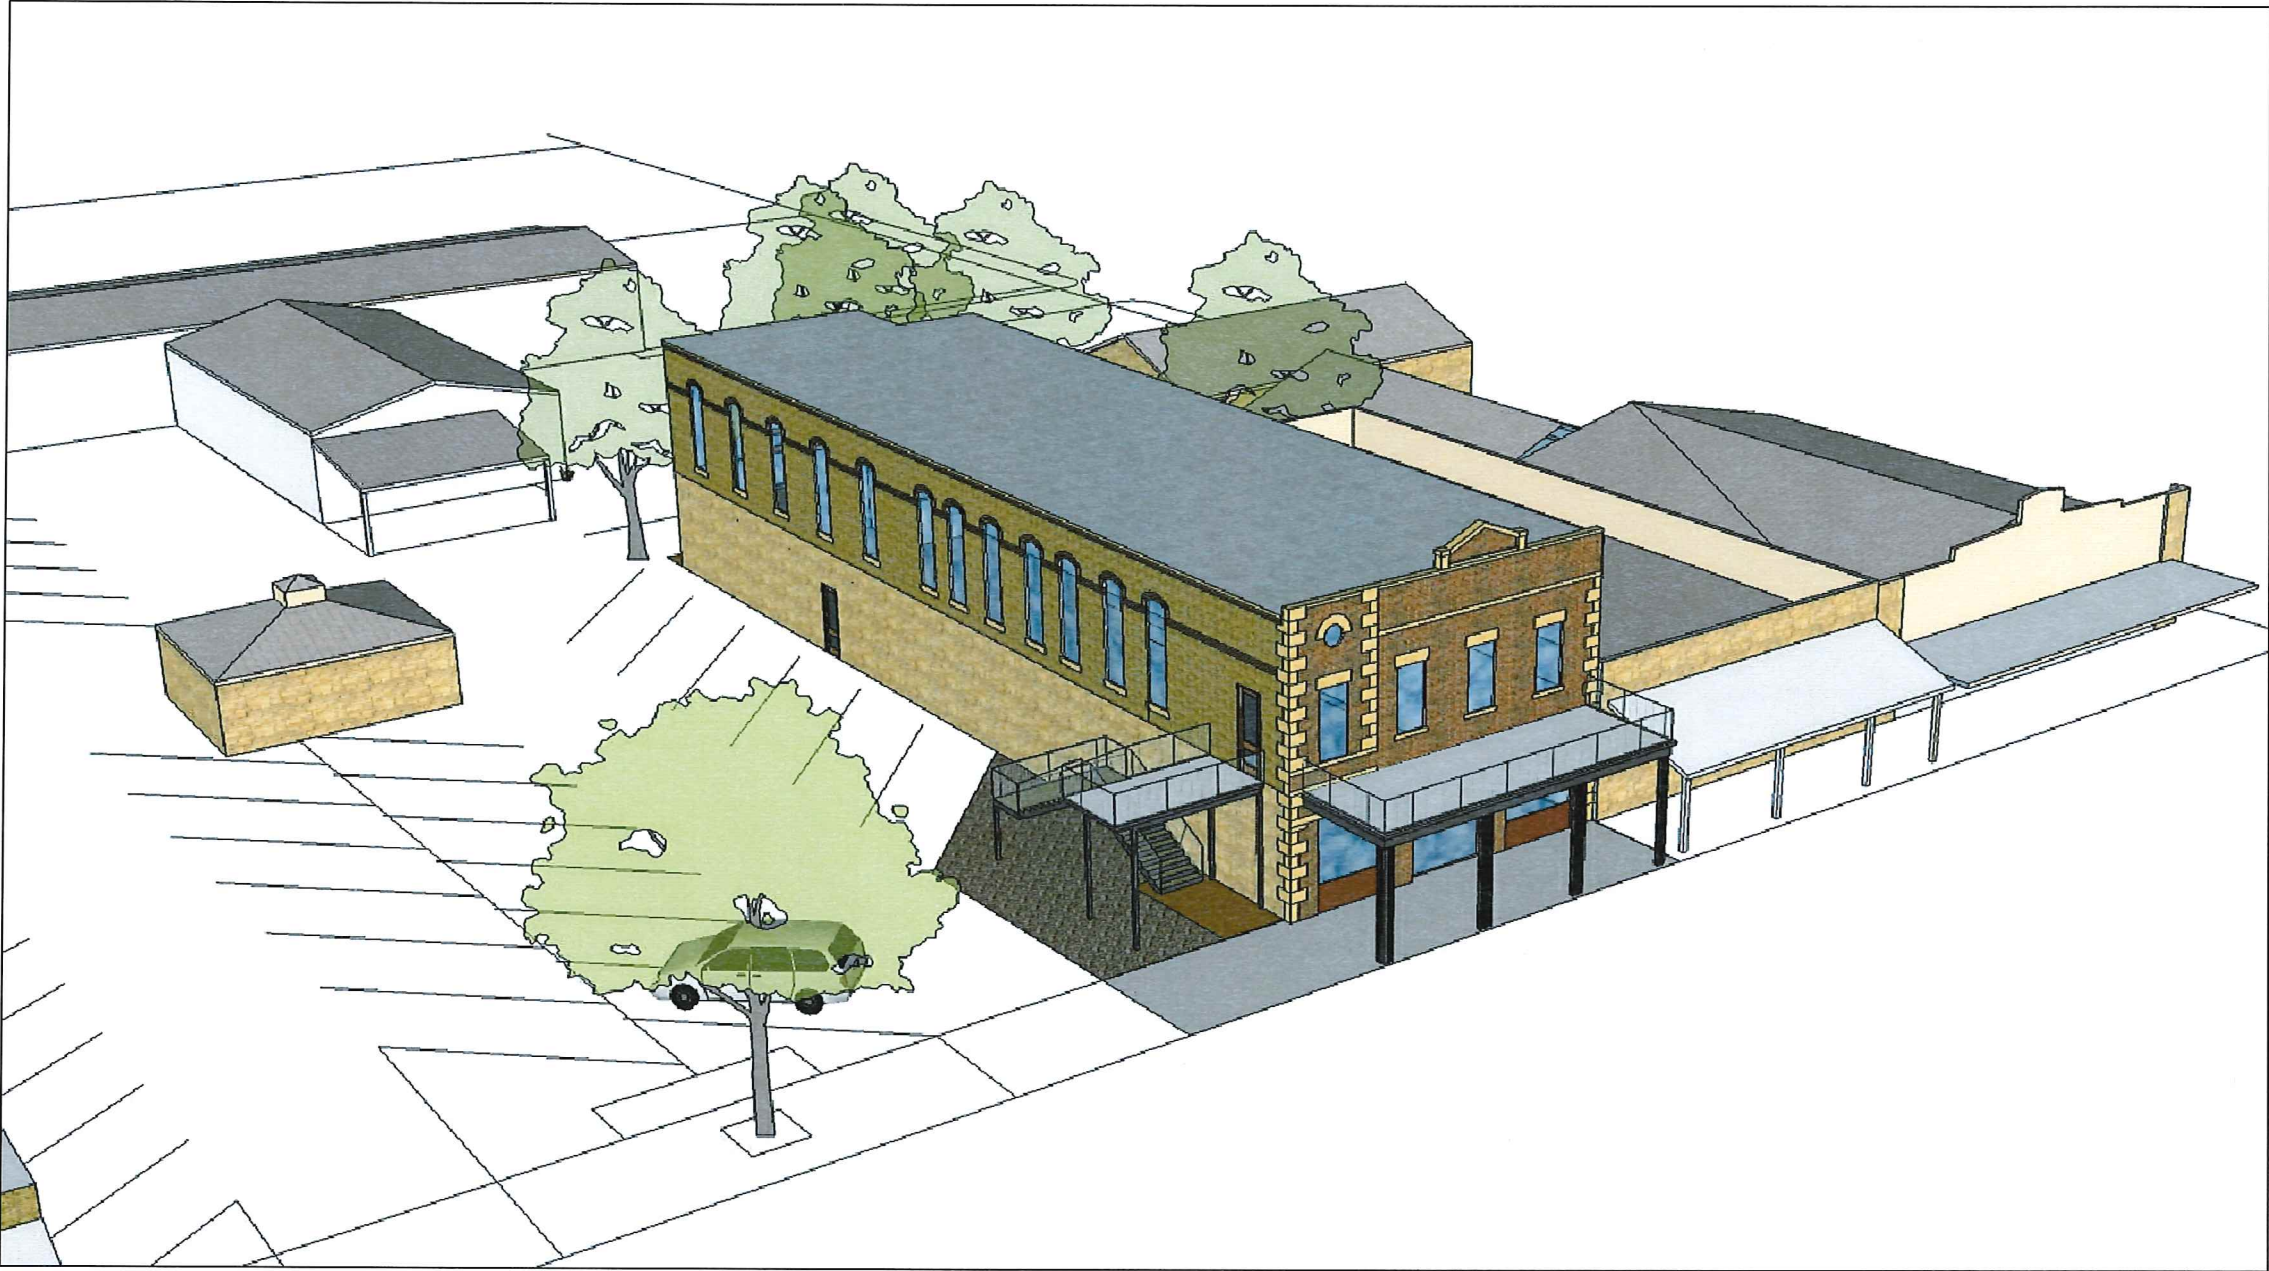
NORTHWEST VIEW OFF MAIN STREET

1. EXISTING WOOD WINDOW ASSEMBLY / REPLACE ALL DAMAGED GLASS PANELS / RECAULK ALL JOINTS / PAINT ALL WOOD FRAMES COMPLETE
2. EXISTING LIMESTONE TO REMAIN / PRESSURE WASH ALL EXPOSED SURFACES

3. EXISTING BRICK VENEER TO REMAIN / PRESSURE WASH ALL EXPOSED SURFACES
4. EXISTING DOOR ASSEMBLY TO REMAIN / PAINT ALL EXPOSED SURFACES
5. EXISTING WOOD WINDOW ASSEMBLY / REPLACE ALL DAMAGED GLASS PANELS / RECAULK ALL JOINTS / PAINT ALL WOOD FRAMES COMPLETE

6. EXISTING LIMESTONE TO REMIAN / PRESSURE WASH ALL EXPOSED SURFACES
7. EXISTING BRICK VENEER TO REMAIN . PRESSURE WASH ALL EXPOSED SURFACES
8. EXISTING DOOR ASSEMBLY TO REMAIN / PAINT ALL EXPOSED SURFACES

9. STANDING SEAM METAL ROOFING SYSTEM / PRE-FINISHED
10. CORRIGATED "S" DECK METAL WALL PANEL (BARN TIN) / GALVANIZED FINISH
11. WOOD FASCIA TRIM / PAINT

12. STAIR AND LANDING ASSEMBLY / CONCRETE TREADS AND LANDINGS - FLAMED FINISH / 6" X 6" STEEL POST WITH COLLARS / EXPOSED TUBE STEEL BEAMS / ALL STEEL SHALL BE PAINTED

13. GUARDRAIL / HANDRAIL ASSEMBLY / 1" X 1 1/2" 14 GAUGE TOP RAIL / 1/2" X 1/2" 16 GAUGE VERTICAL PICKETS AT 4" O.C. WITH 1 1/2" X 1 1/2" 11 GAUGE HORIZONTAL RAIL / ALL STEEL SHALL BE PAINTED

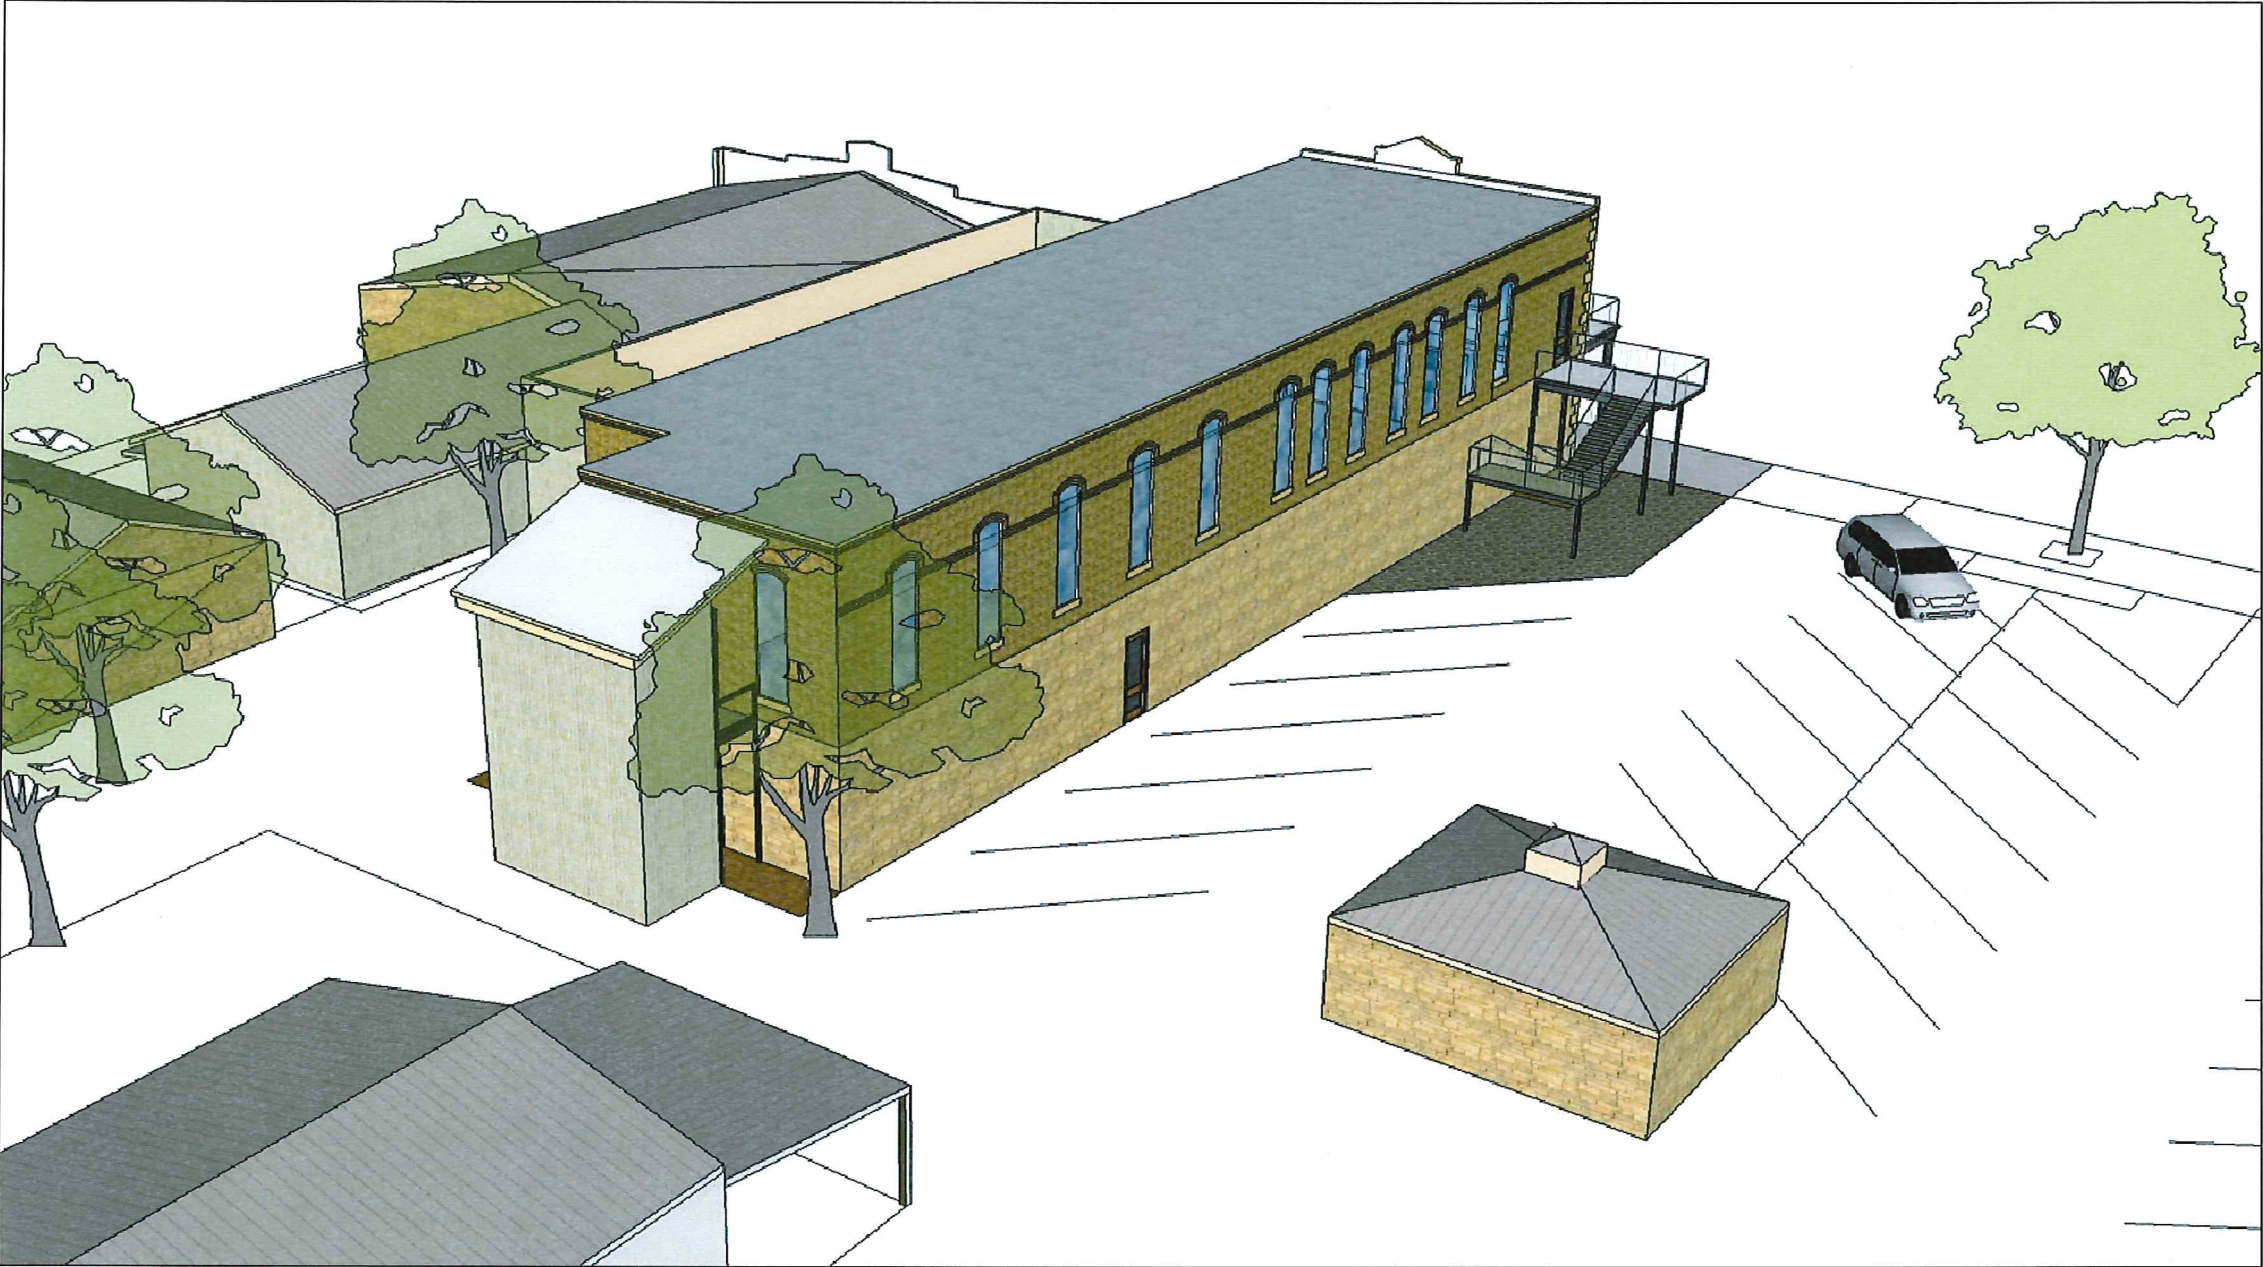
NORTH EAST VIEW

1. EXISTING WOOD WINDOW ASSEMBLY / REPLACE ALL DAMAGED GLASS PANELS / RECAULK ALL JOINTS / PAINT ALL WOOD FRAMES COMPLETE
2. EXISTING LIMESTONE TO REMAIN / PRESSURE WASH ALL EXPOSED SURFACES

3. EXISTING BRICK VENEER TO REMAIN / PRESSURE WASH ALL EXPOSED SURFACES
4. EXISTING DOOR ASSEMBLY TO REMAIN / PAINT ALL EXPOSED SURFACES
5. EXISTING WOOD WINDOW ASSEMBLY / REPLACE ALL DAMAGED GLASS PANELS / RECAULK ALL JOINTS / PAINT ALL WOOD FRAMES COMPLETE

6. EXISTING LIMESTONE TO REMIAN / PRESSURE WASH ALL EXPOSED SURFACES
7. EXISTING BRICK VENEER TO REMAIN . PRESSURE WASH ALL EXPOSED SURFACES
8. EXISTING DOOR ASSEMBLY TO REMAIN / PAINT ALL EXPOSED SURFACES

9. STANDING SEAM METAL ROOFING SYSTEM / PRE-FINISHED
10. CORRIGATED "S" DECK METAL WALL PANEL (BARN TIN) / GALVANIZED FINISH
11. WOOD FASCIA TRIM / PAINT

12. STAIR AND LANDING ASSEMBLY / CONCRETE TREADS AND LANDINGS - FLAMED FINISH / 6" X 6" STEEL POST WITH COLLARS / EXPOSED TUBE STEEL BEAMS / ALL STEEL SHALL BE PAINTED

13. GUARDRAIL / HANDRAIL ASSEMBLY / 1" X 1 1/2" 14 GAUGE TOP RAIL / 1/2" X 1/2" 16 GAUGE VERTICAL PICKETS AT 4" O.C. WITH 1 1/2" X 1 1/2" 11 GAUGE HORIZONTAL RAIL / ALL STEEL SHALL BE PAINTED
