2016.09.23| HISTORICAL REVIEW SUBMISSION

ZIEGLER BUILDING DEVELOPMENT
COLORADO RIVER PROPERTIES, LLC.
Boerne, Texas

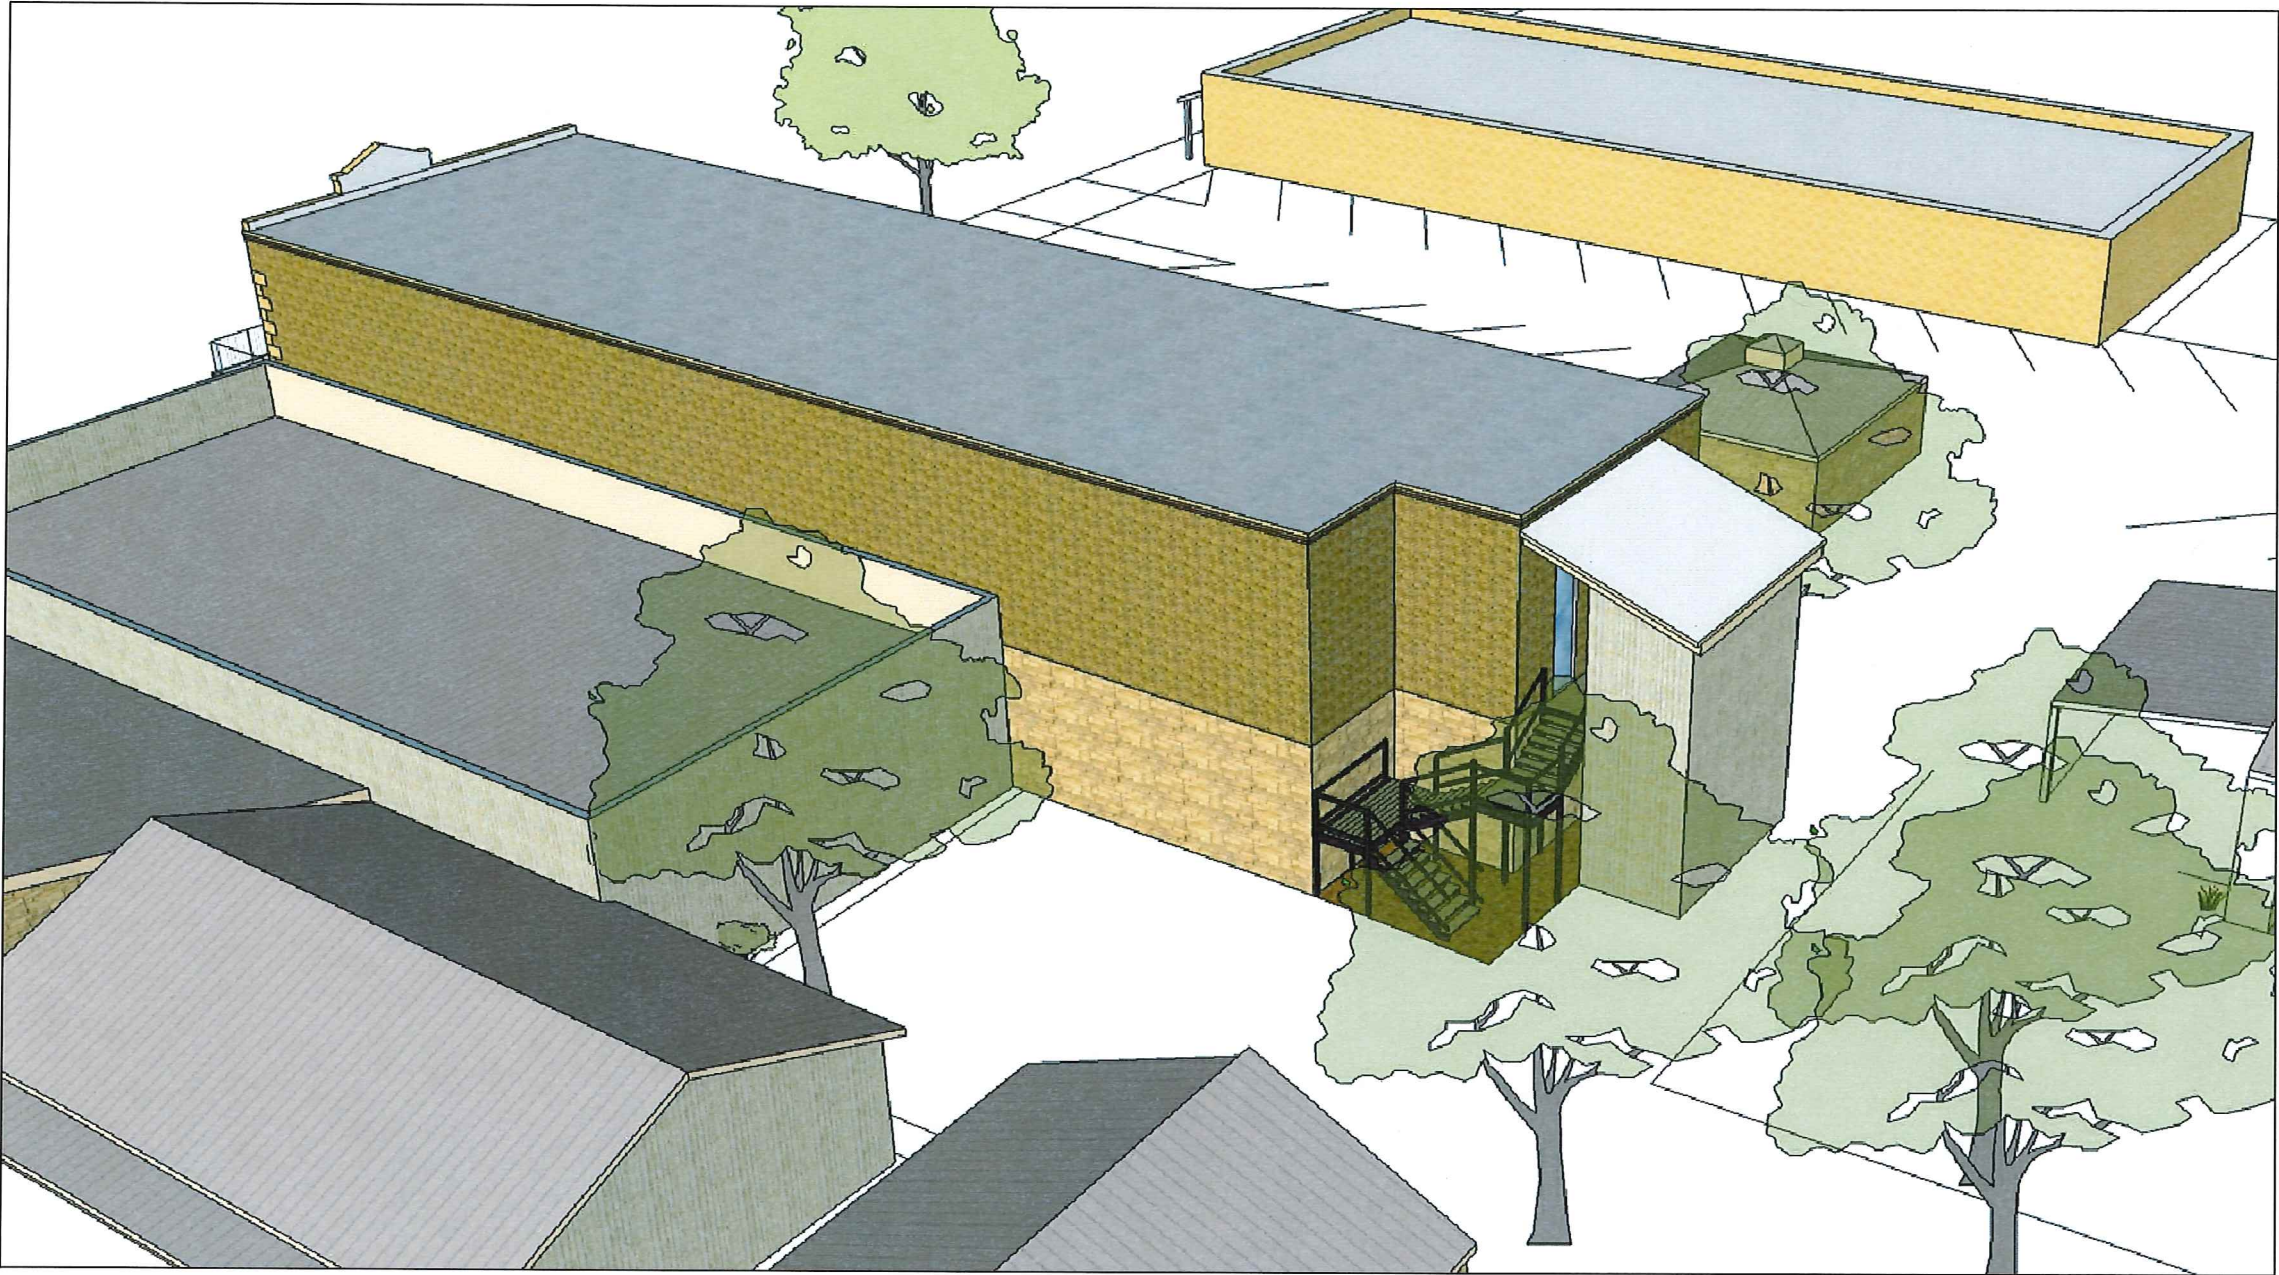
SOUTH EAST VIEW

1. EXISTING WOOD WINDOW ASSEMBLY / REPLACE ALL DAMAGED GLASS PANELS / RECAULK ALL JOINTS / PAINT ALL WOOD FRAMES COMPLETE
2. EXISTING LIMESTONE TO REMAIN / PRESSURE WASH ALL EXPOSED SURFACES

3. EXISTING BRICK VENEER TO REMAIN / PRESSURE WASH ALL EXPOSED SURFACES
4. EXISTING DOOR ASSEMBLY TO REMAIN / PAINT ALL EXPOSED SURFACES
5. EXISTING WOOD WINDOW ASSEMBLY / REPLACE ALL DAMAGED GLASS PANELS / RECAULK ALL JOINTS / PAINT ALL WOOD FRAMES COMPLETE

6. EXISTING LIMESTONE TO REMIAN / PRESSURE WASH ALL EXPOSED SURFACES
7. EXISTING BRICK VENEER TO REMAIN . PRESSURE WASH ALL EXPOSED SURFACES
8. EXISTING DOOR ASSEMBLY TO REMAIN / PAINT ALL EXPOSED SURFACES

9. STANDING SEAM METAL ROOFING SYSTEM / PRE-FINISHED
10. CORRIGATED "S" DECK METAL WALL PANEL (BARN TIN) / GALVANIZED FINISH
11. WOOD FASCIA TRIM / PAINT

12. STAIR AND LANDING ASSEMBLY / CONCRETE TREADS AND LANDINGS - FLAMED FINISH / 6" X 6" STEEL POST WITH COLLARS / EXPOSED TUBE STEEL BEAMS / ALL STEEL SHALL BE PAINTED

13. GUARDRAIL / HANDRAIL ASSEMBLY / 1" X 1 1/2" 14 GAUGE TOP RAIL / 1/2" X 1/2" 16 GAUGE VERTICAL PICKETS AT 4" O.C. WITH 1 1/2" X 1 1/2" 11 GAUGE HORIZONTAL RAIL / ALL STEEL SHALL BE PAINTED
