AGENDA
HISTORIC LANDMARK COMMISSION MEETING
RONALD C. BOWMAN CITY COUNCIL CHAMBERS
447 NORTH MAIN STREET
Tuesday, April 1, 2025 - 5:30 PM

Agenda Date	April 1, 2025
Requested Action	Consider a request for a demolition permit for the structures located at 308 W San Antonio.
Contact Person	Sara Varvarigos, Planner II, Staff Liaison to the Historic Landmark Commission (830) 248-1630, svarvarigos@boerne-tx.gov
Case Number	2025-04-005A
Subject Property	308 W San Antonio
Background Information	<p>BACKGROUND:</p> <ul style="list-style-type: none"> • Applicant/Owner: Lisa Blank on behalf of BEATH DORIS E MARITAL TRUST • Structure Description: The primary structure located at 308 W San Antonio Ave was built in 1952 as a single-family residence. • Historic District Status: The subject property is not located within the Historic District but is older than 50 years (Attachment 1 & 2). • Zoning: R2-M Transitional Residential <p>REQUEST:</p> <p>The property owner is requesting a consideration of:</p> <ol style="list-style-type: none"> 1. A building demolition permit request for structure(s) located at 308 W San Antonio (Attachment 3). <p>ANALYSIS:</p> <p>The residence previously belonged to Mrs.

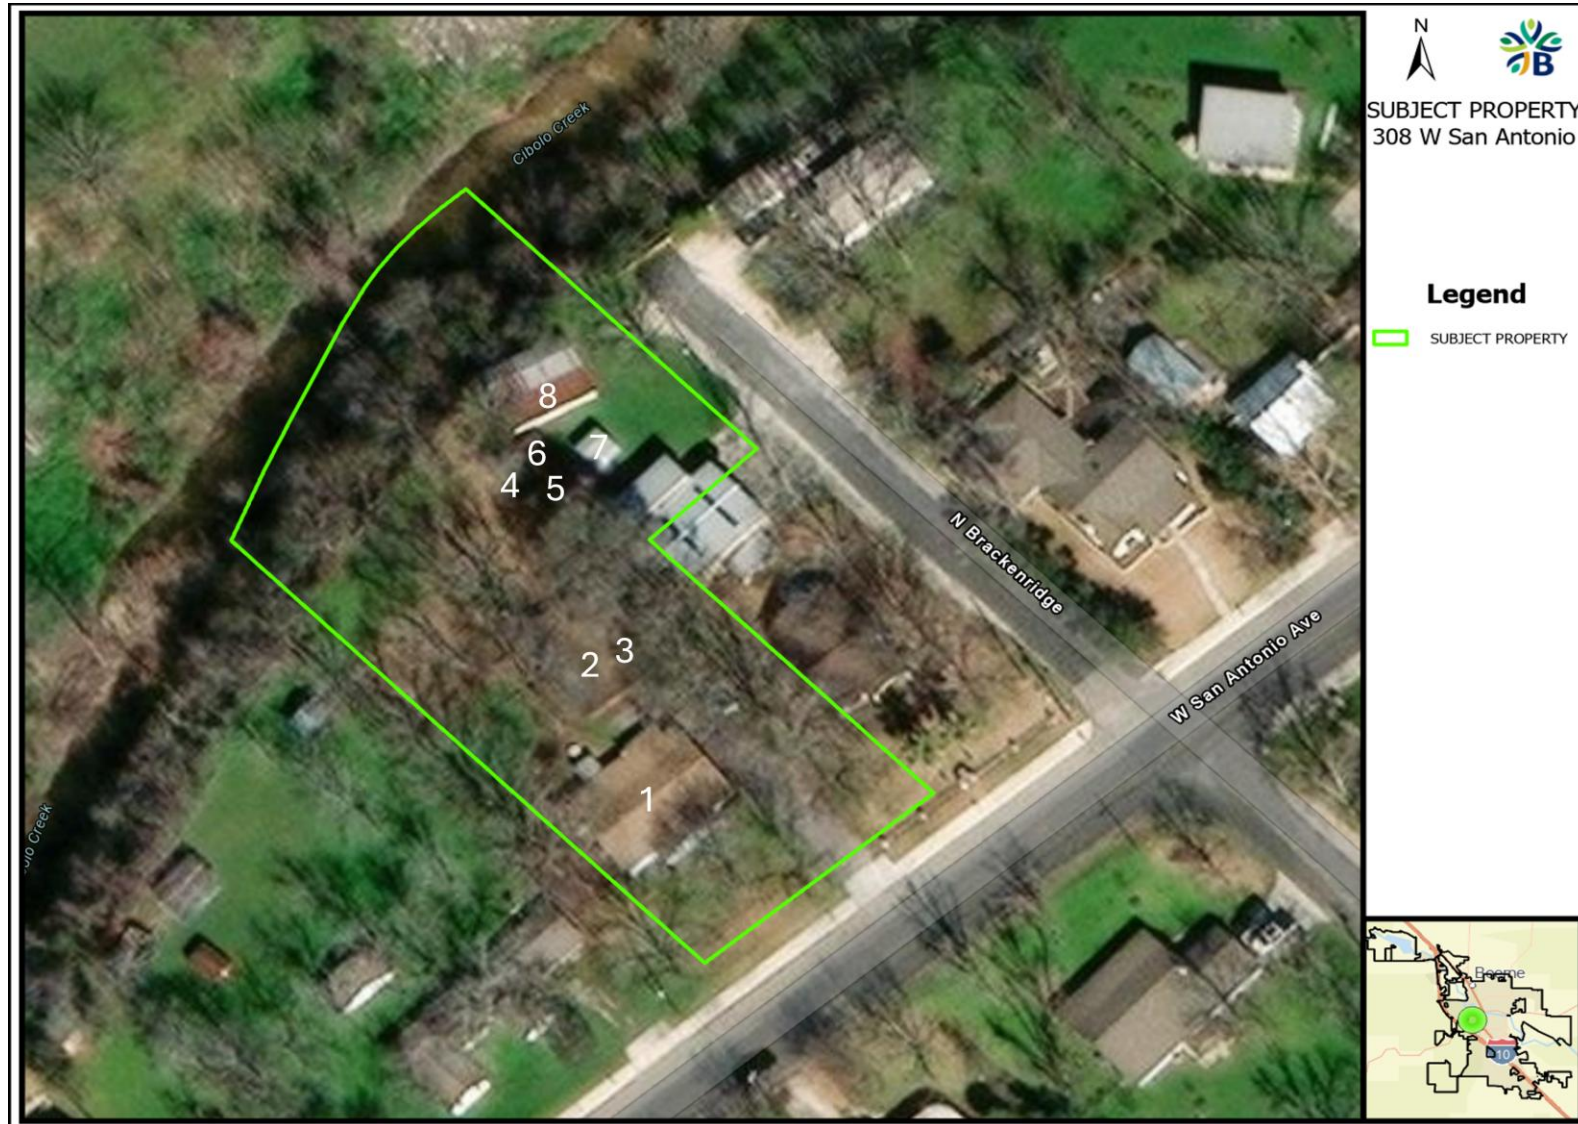
Site Map for 308 W San Antonio

A Historic Landmark Commission site visit was performed on March 7, 2025, to gather additional data on the condition of the structures at 308 W San Antonio. The site visit notes for each building are summarized below, with corresponding building locations and site visit photos presented in attachment 3:

Building No.	Building Description	Demolition Requested (Y/N)
1	Single Family Residence	Y
2	Workshop	Y
3	Open Air Shed	Y
4	Shed	Y
5	Well House	N
6	Shed	Y
7	Tuff Shed	N
8	Shed	Y

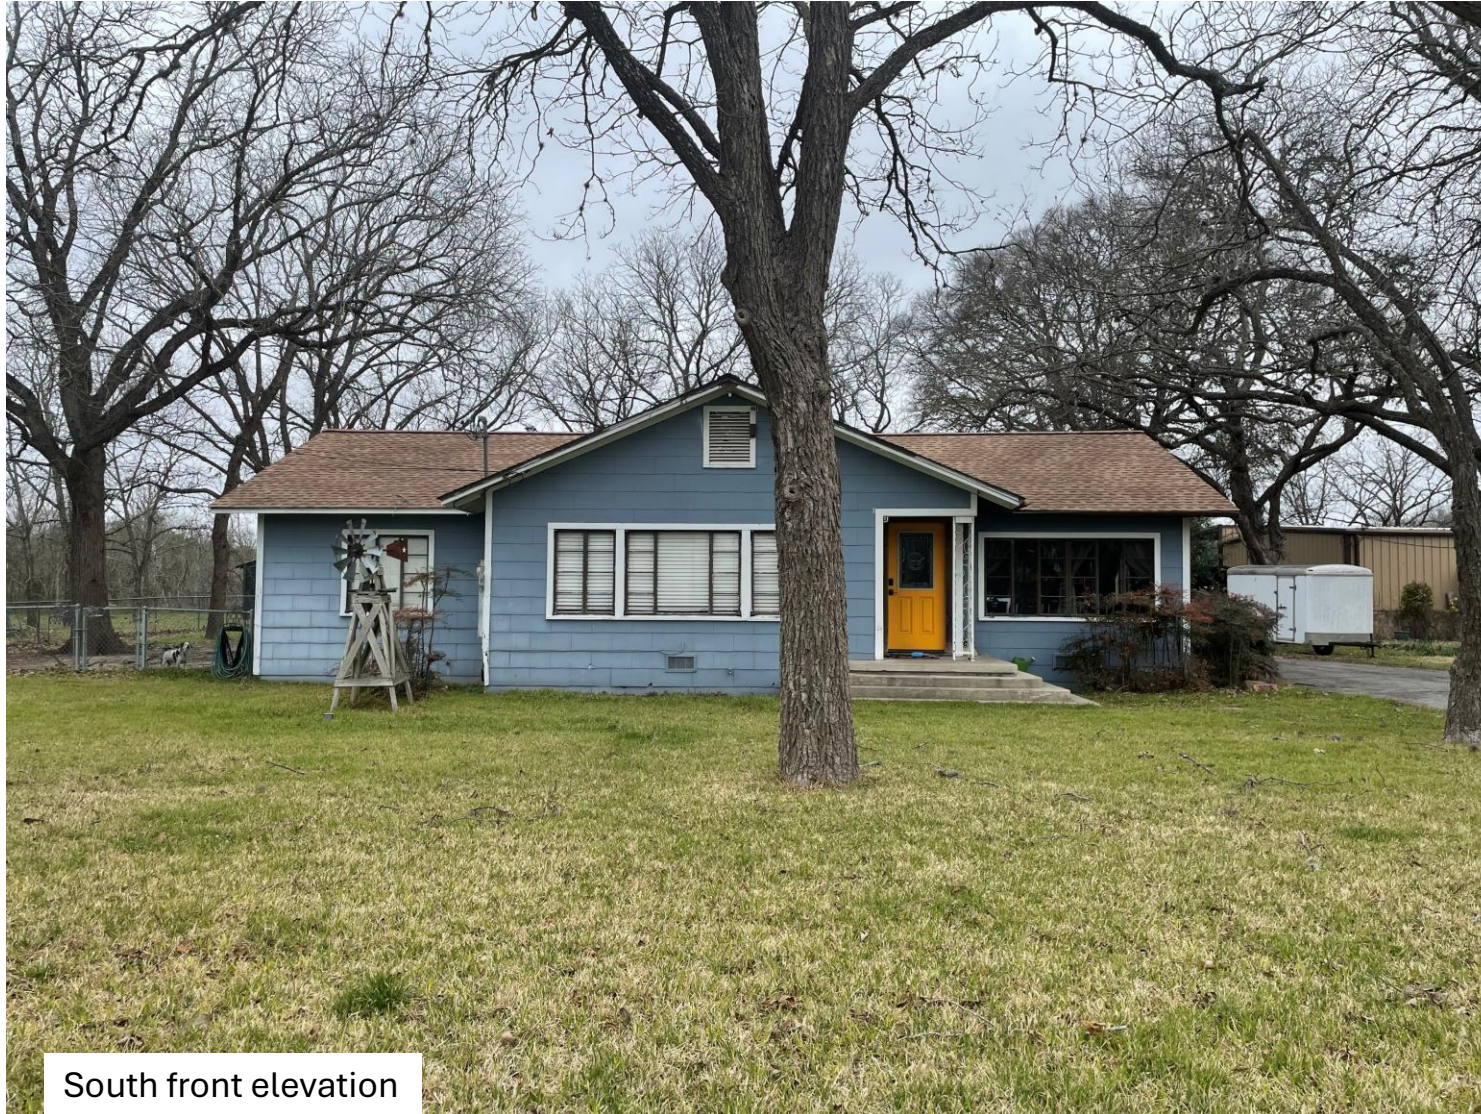
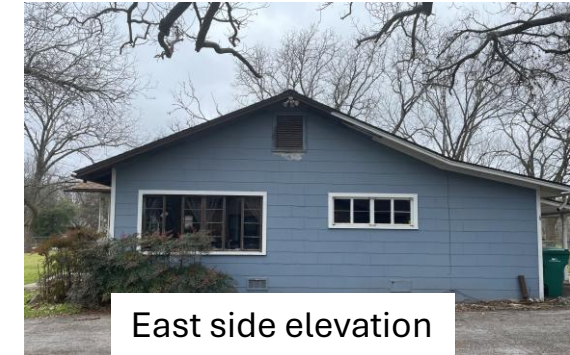
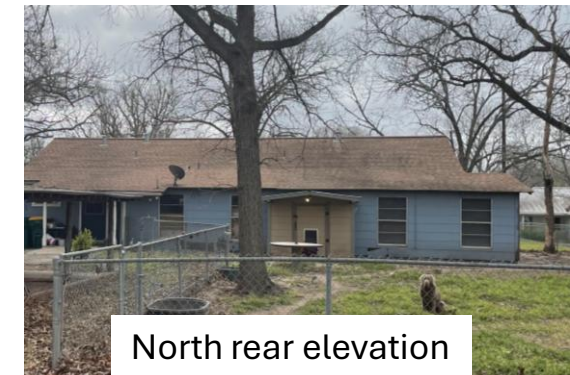
HLC Site Visit Photos: 1. Single Family Residence – Demolition Requested

1. A single family residence built in 1952 features a one-story bungalow façade, with weathered blue shingle-style siding and a cross gable roof. Demolition is requested for this structure.
 - The shingle-style siding is weathered and broken in multiple areas.
 - The front door does not appear to be original to the building.
 - The casement windows along the front and side elevations appear to be original to the building's 1950's era construction, while the rear windows appear to be aluminum frame windows from a later period.

<ul style="list-style-type: none"> ○ The property is partially enclosed by a chain link fence, which is not permitted as per Section 4.4.D of the Unified Development Code. ○ The property features an abundance of large mature heritage trees <ol style="list-style-type: none"> 2. A workshop located behind the residence features blue siding similar to the residential structure. The shed style roof appears to be weathered and warped. Demolition is requested for this structure. 3. A wood frame open air shed in dilapidated condition, with rotted wooden boards and posts. Demolition is requested for this structure. 4. A corrugated metal shed with some evidence of weathering. Demolition is requested for this structure. 5. A stone facade well house in excellent condition. No demolition is requested for this structure. 6. A corrugated metal shed with some evidence of weathering. Demolition is requested for this structure. 7. A “Tuff Shed” belonging to the neighboring property owner. This structure will be relocated, and no demolition is requested for this structure. 8. A wood and particle board shed with corrugated metal roof, with evidence of weathering and rot. Demolition is requested for this structure. <p>FINDINGS:</p> <p>The existing primary residence has broken and degraded shingle-style siding in multiple areas. While it appears to have limited elements of architectural value, such as the original casement windows on portions of the original structure, the front door and rear windows appear to be from a later period, reducing the architectural integrity of the structure.</p> <p>The residence has an element of cultural value, as the former residence of one of Boerne’s longest-tenured and well-known schoolteachers, Mrs. Viola Wilson. Mrs. Wilson’s contribution to the education of several generations of Boerne’s schoolchildren has been memorialized through the naming of Boerne ISD’s newest elementary school in her honor.</p>

<p>The accessory structures do not appear to have any architectural value. The Planning Department considers that the demolition request for structures 1, 2, 3, 4, 6 and 8 is appropriate, also noting the property owner's successful efforts to memorialize Mrs. Viola Wilson's contributions to the culture, and education of the community of Boerne through the naming of a new elementary school in her honor.</p> <p>RECOMMENDATION:</p> <p>Staff finds that the proposed demolition of structures 1, 2, 3, 4, 6 and 8 is appropriate, with the following stipulations:</p> <ol style="list-style-type: none"> 1. The chain link fence on the property be removed as part of the demolition 2. The mature heritage trees on site be preserved if they are in good health. <p>MOTIONS FOR CONSIDERATION:</p> <p>The following motions are provided to assist the Commission's decision.</p> <p>I move that the Historic Landmark Commission accepts staff findings and APPROVE a demolition permit request for structures 1, 2, 3, 4, 6 and 8, with staff stipulations</p> <p>OR</p> <p>I move that the Historic Landmark Commission rejects the findings and DENY a demolition permit request. (The Commission will need to state the reasons for the denial. These reasons should reference specific regulations in the UDC).</p>

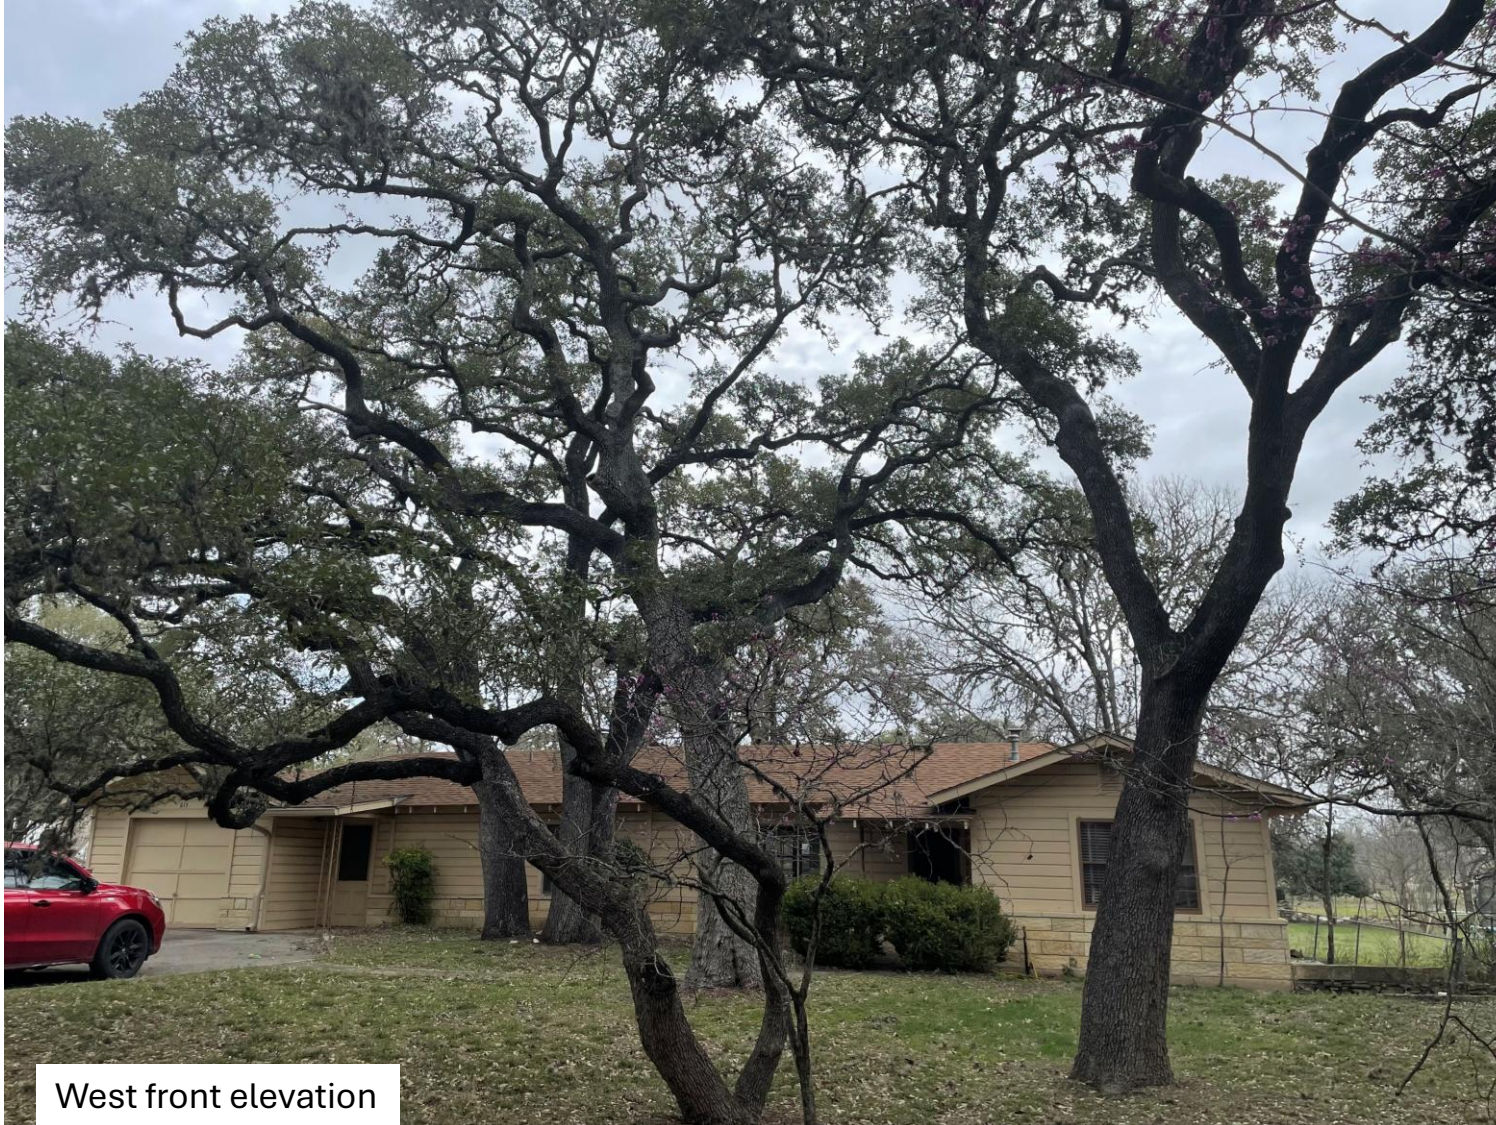
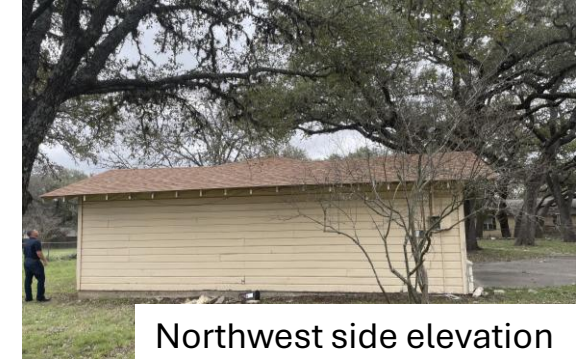
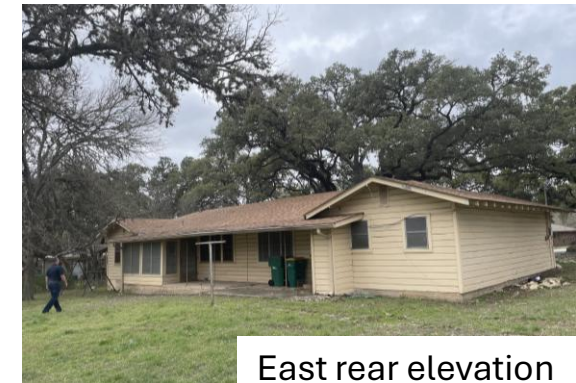
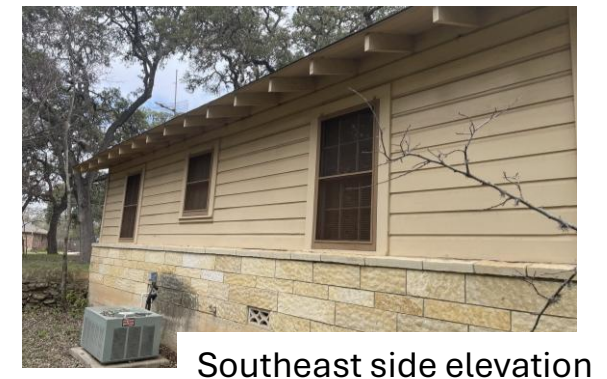
Site Visit Photos: Single Family Residence – Demolition Requested

<ul style="list-style-type: none"> • The residence is a one-story ranch style home with a single car garage, featuring wood siding and limestone veneer. • The doors and windows of the home appear to be largely original, with a combination of original double-hung windows and aluminum framed windows from a later era. • The property is enclosed by a chain link fence, which is not permitted as per Section 4.4.D of the Unified Development Code. • The property features an abundance of large mature heritage trees. <p>The property does not appear to have architectural, cultural, or educational value.</p> <p>RECOMMENDATION:</p> <p>Staff finds that the proposed demolition of the primary residence is appropriate, with the following stipulations:</p> <ol style="list-style-type: none"> 1. The chain link fence on the property be removed as part of the demolition. 2. The mature heritage trees on site be preserved if they are in good health. <p>MOTIONS FOR CONSIDERATION:</p> <p>The following motions are provided to assist the Commission’s decision.</p> <p>I move that the Historic Landmark Commission accepts staff findings and APPROVE a demolition permit request with staff stipulations.</p> <p>OR</p> <p>I move that the Historic Landmark Commission rejects the findings and DENY a demolition permit request. (The Commission will need to state the reasons for the denial. These reasons should reference specific regulations in the UDC).</p>

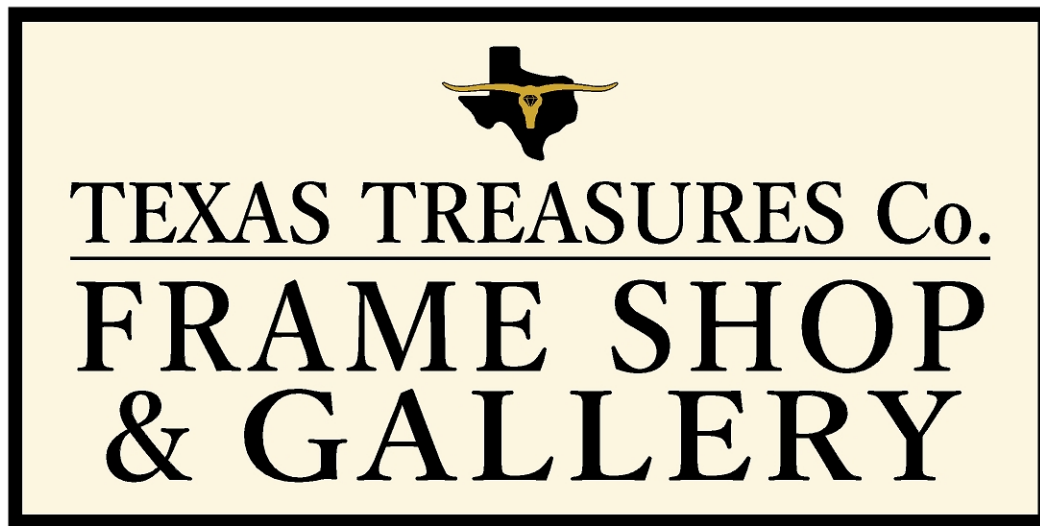
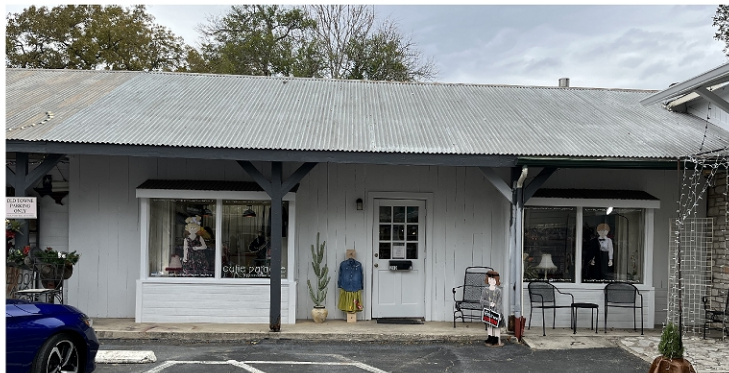
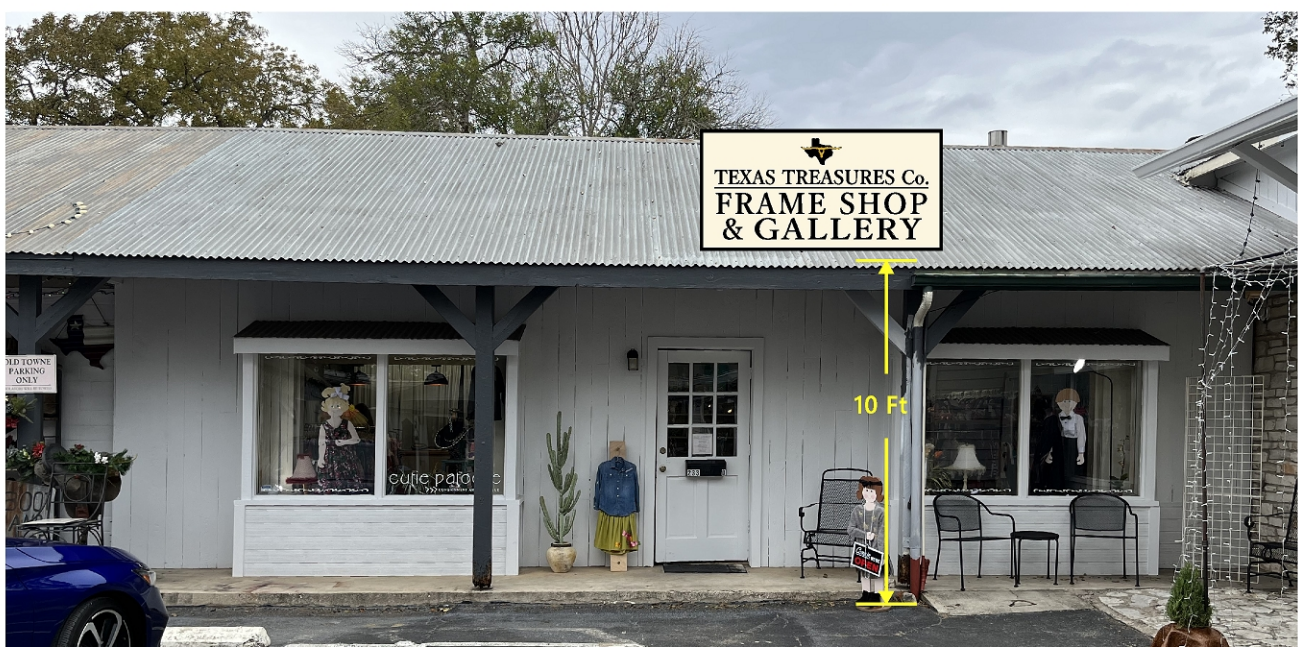
Roof Top Sign 4' x 8' MaxMetal Single Face

<p>the following details:</p> <ul style="list-style-type: none"> • Metal rectangular sign panel measuring 48” H x 96” W • Beige background with black serif type font • Non-lit sign <p>The proposed sign design follows several Historic District guidelines for signs:</p> <ul style="list-style-type: none"> • Metal material • Max 2 fonts • Less than 4 colors • Earth colors • Complements building façade <p>RECOMMENDATION:</p> <p>Based on its alignment with the Comprehensive Master Plan, UDC Chapter 3.11 and 9, and Historic District Design Guidelines, staff recommends that the Historic Landmark Commission APPROVE a certificate of appropriateness for a new sign at 231 S. Main, Suite D. (Texas Treasures Co. Frame Shop & Gallery)</p> <p>MOTIONS FOR CONSIDERATION:</p> <p>The following motions are provided to assist the Commission’s decision.</p> <p>I move that the Historic Landmark Commission accepts the findings and APPROVE a certificate of appropriateness for a new sign.</p> <p>OR</p> <p>I move that the Historic Landmark Commission rejects the findings and DENY a certificate of appropriateness for a new sign. (The Commission will need to state the reasons for the denial. These reasons should reference specific regulations in the UDC).</p>

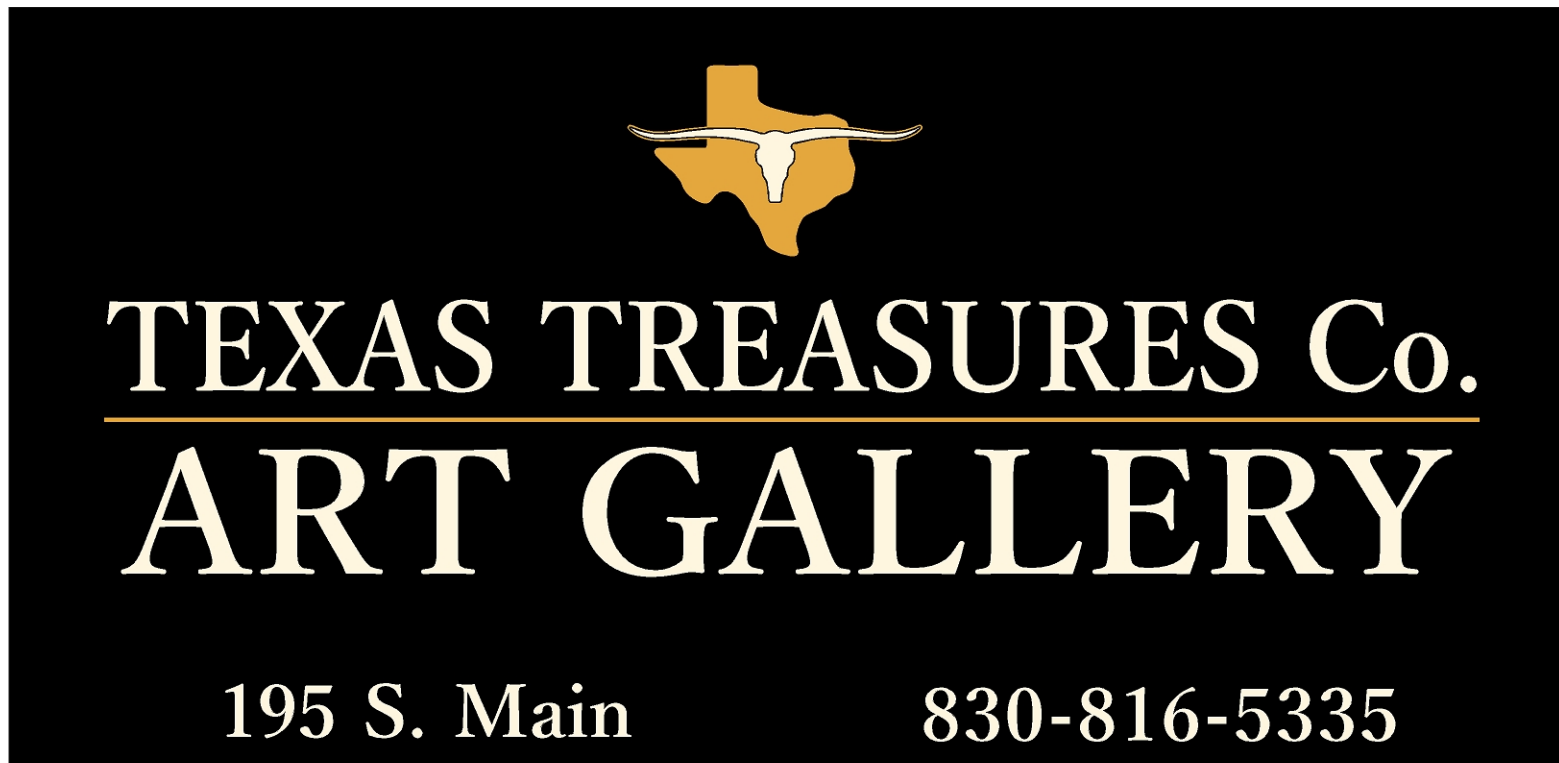
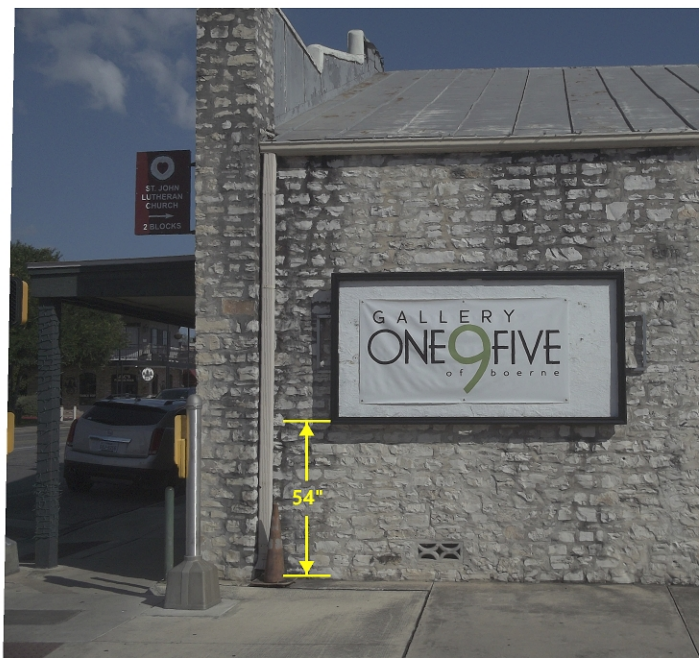
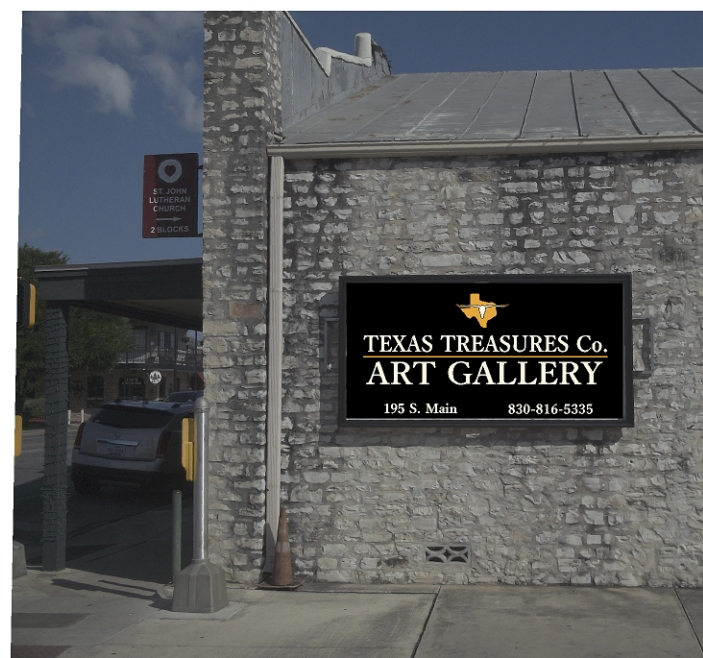
Wall Sign
48" x 96" MaxMetal Sign, Single Face

<ul style="list-style-type: none"> • Metal rectangular sign panel measuring 48" H x 96" W • Black background with beige serif type font • Non-lit sign <p>The proposed sign design follows several Historic District guidelines for signs:</p> <ul style="list-style-type: none"> • Metal material • Max 2 fonts • Less than 4 colors • Earth colors • Complements building façade <p>RECOMMENDATION:</p> <p>Based on its alignment with the Comprehensive Master Plan, UDC Chapter 3.11 and 9, and Historic District Design Guidelines, staff recommends that the Historic Landmark Commission APPROVE a certificate of appropriateness for a new sign at 195 S. Main Street (Suite A).</p> <p>MOTIONS FOR CONSIDERATION:</p> <p>The following motions are provided to assist the Commission's decision.</p> <p>I move that the Historic Landmark Commission accepts the findings and APPROVE a certificate of appropriateness for a new sign.</p> <p>OR</p> <p>I move that the Historic Landmark Commission rejects the findings and DENY a certificate of appropriateness for a new sign. (The Commission will need to state the reasons for the denial. These reasons should reference specific regulations in the UDC).</p>

(sign to mount in existing frame on wall)

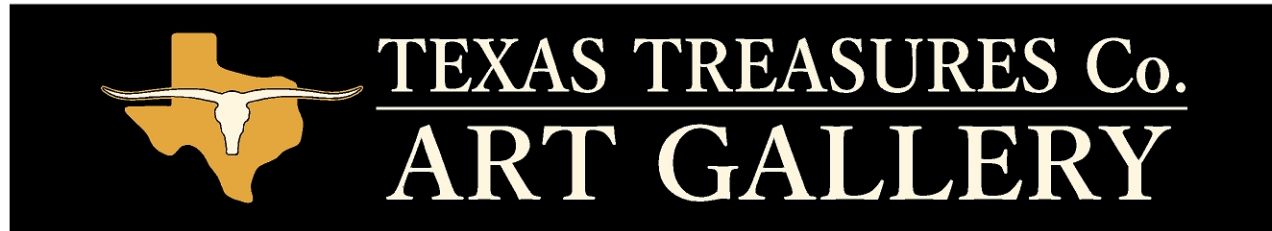
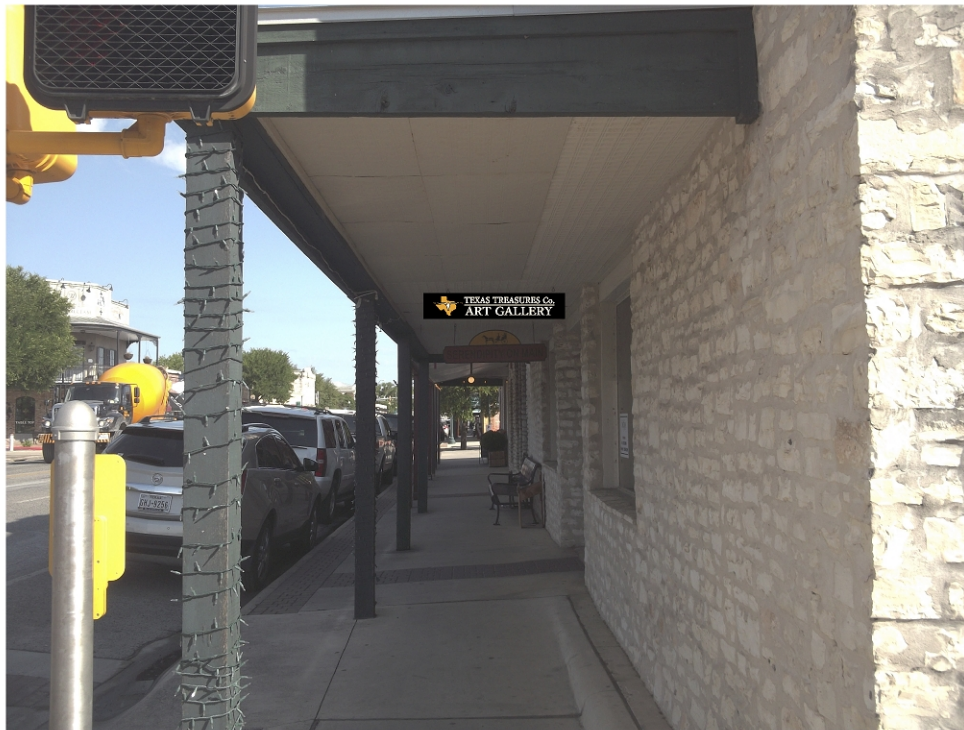
1 - 5" x 28' Double Face, MDO

<ul style="list-style-type: none"> • Wooden rectangular sign panel measuring 5" W x 28" H • Black background with beige serif type font • Non-lit sign <p>The proposed sign design follows several Historic District guidelines for signs:</p> <ul style="list-style-type: none"> • Metal material • Max 2 fonts • Less than 4 colors • Earth colors • Complements building façade <p>RECOMMENDATION:</p> <p>Based on its alignment with the Comprehensive Master Plan, UDC Chapter 3.11 and 9, and Historic District Design Guidelines, staff recommends that the Historic Landmark Commission APPROVE a certificate of appropriateness for a new sign located at 195 South Main Street, Suite A. (Texas Treasures Co. Art Gallery)</p> <p>MOTIONS FOR CONSIDERATION:</p> <p>The following motions are provided to assist the Commission's decision.</p> <p>I move that the Historic Landmark Commission accepts the findings and APPROVE a certificate of appropriateness for a new sign.</p> <p>OR</p> <p>I move that the Historic Landmark Commission rejects the findings and DENY a certificate of appropriateness for a new sign. (The Commission will need to state the reasons for the denial. These reasons should reference specific regulations in the UDC).</p>

(96" from the ground to the bottom of the sign)
