PROPOSED FLOOR PLAN

2018.09.21 HISTORICAL REVIEW SUBMISSION

**ZIEGLER BUILDING DEVELOPMENT**  
**COLORADO RIVER PROPERTIES, LLC.**  
Boerne, Texas

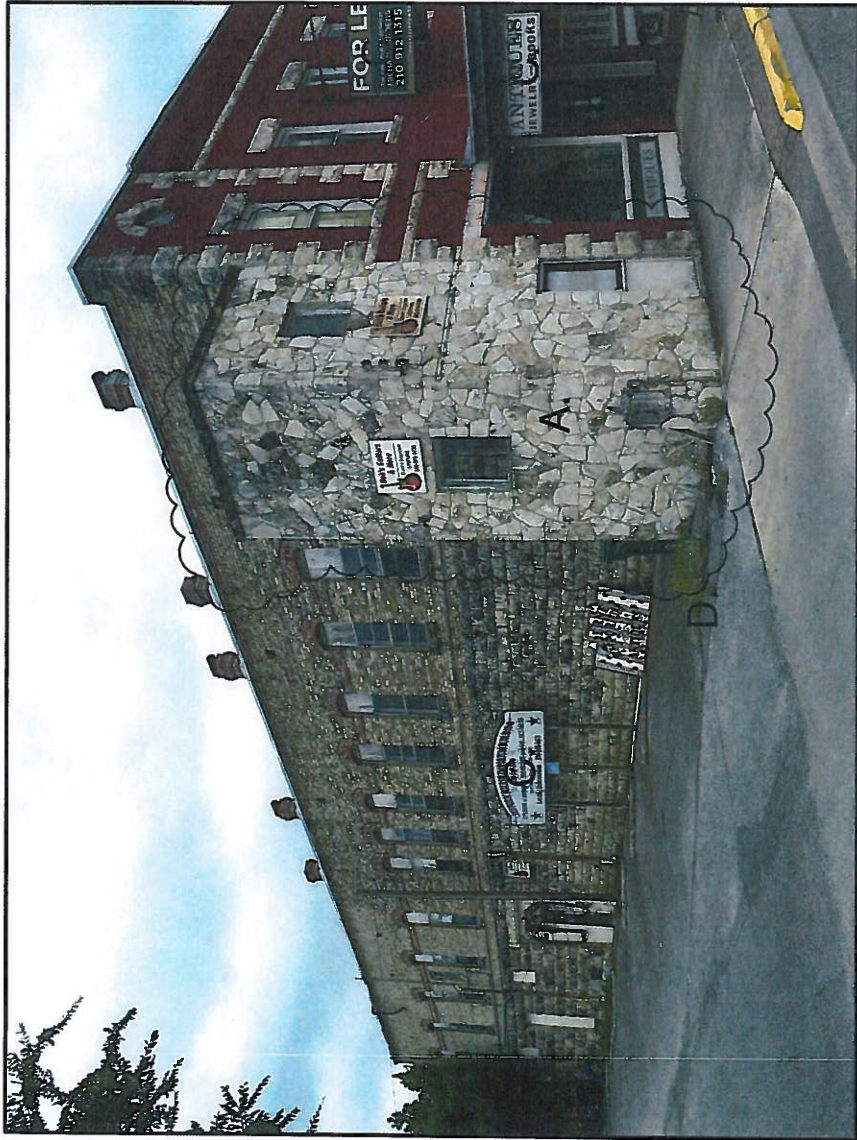
EXISTING IMAGE- NORTH WEST CORNER

- A. REMOVE EXISTING TOWER COMPLETE
- B. REMOVE EXISTING CANOPY COMPLETE
- C. REMOVE EXISTING SIGNAGE COMPLETE
- D. REMOVE EXISTING ASPHALT PAVING COMPLETE WHERE NEW CONSTRUCTION OCCURS
- E. REMOVE EXISTING STAIRWAY COMPLETE / COORDINATE WITH NEW CONSTRUCTION OCCURS

- 1. EXISTING WOOD WINDOW ASSEMBLY / REPLACE ALL DAMAGED GLASS PANELS / RECAULK ALL JOINTS / PAINT ALL WOOD FRAMES COMPLETE
- 2. EXISTING LIMESTONE TO REMAIN / PRESSURE WASH ALL EXPOSED SURFACES
- 3. EXISTING BRICK VENEER TO REMAIN / PRESSURE WASH ALL EXPOSED SURFACES
- 4. EXISTING DOOR ASSEMBLY TO REMAIN / PAINT ALL EXPOSED SURFACES
- 5. EXISTING WOOD WINDOW ASSEMBLY / REPLACE ALL DAMAGED GLASS PANELS / RECAULK ALL JOINTS / PAINT ALL WOOD FRAMES COMPLETE
- 6. EXISTING LIMESTONE TO REMAIN / PRESSURE WASH ALL EXPOSED SURFACES
- 7. EXISTING BRICK VENEER TO REMAIN / PRESSURE WASH ALL EXPOSED SURFACES
- 8. EXISTING DOOR ASSEMBLY TO REMAIN / PAINT ALL EXPOSED SURFACES

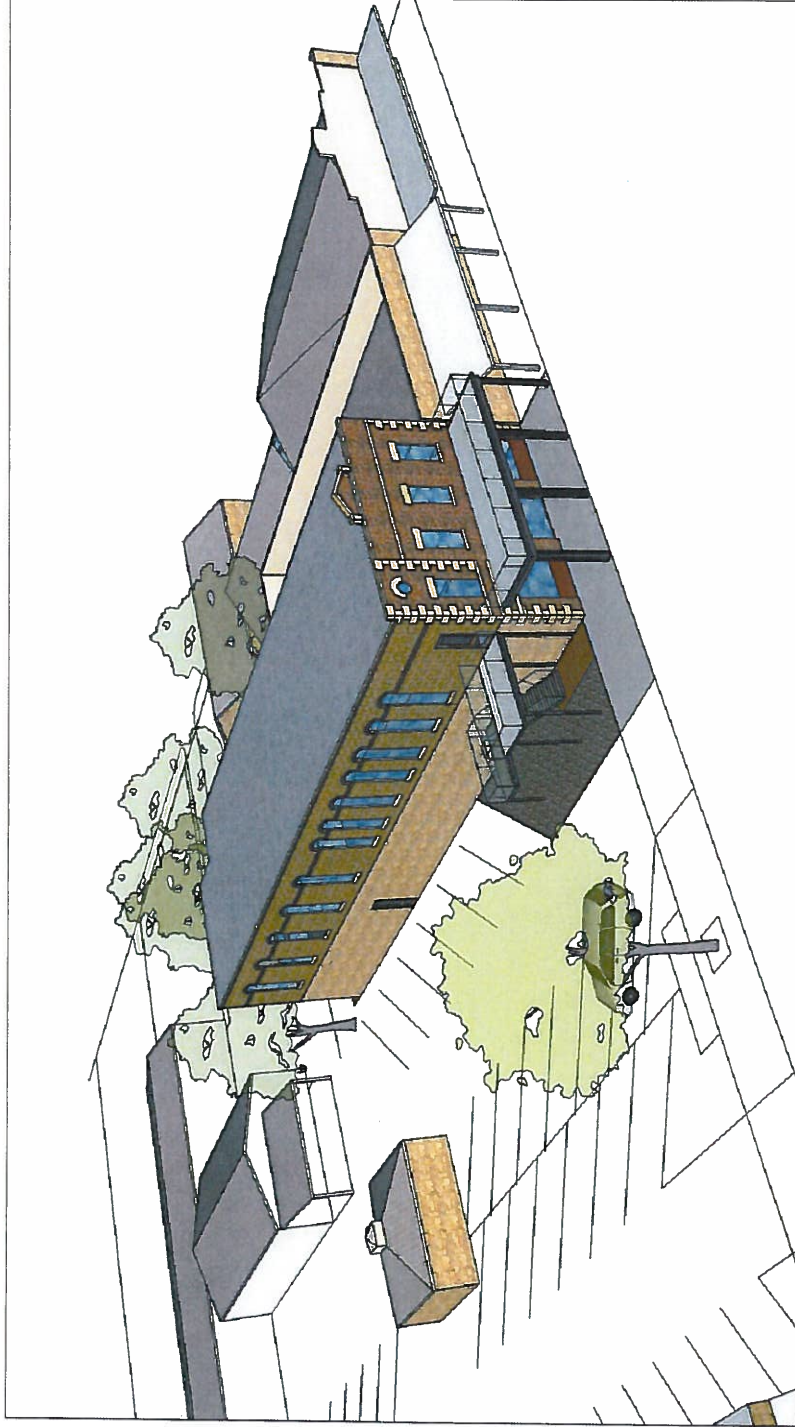
## NORTHWEST VIEW OFF MAIN STREET

1. EXISTING WOOD WINDOW ASSEMBLY /  
REPLACE ALL DAMAGED GLASS PANELS /  
RECAULK ALL JOINTS / PAINT ALL WOOD  
FRAMES COMPLETE
2. EXISTING LIMESTONE TO REMAIN /  
PRESSURE WASH ALL EXPOSED SURFACES

3. EXISTING BRICK VENEER TO REMAIN /  
PRESSURE WASH ALL EXPOSED SURFACES
4. EXISTING DOOR ASSEMBLY TO REMAIN /  
PAINT ALL EXPOSED SURFACES
5. EXISTING WOOD WINDOW ASSEMBLY /  
REPLACE ALL DAMAGED GLASS PANELS /  
RECAULK ALL JOINTS / PAINT ALL WOOD  
FRAMES COMPLETE

6. EXISTING LIMESTONE TO REMAIN /  
PRESSURE WASH ALL EXPOSED SURFACES
7. EXISTING BRICK VENEER TO REMAIN /  
PRESSURE WASH ALL EXPOSED SURFACES
8. EXISTING DOOR ASSEMBLY TO REMAIN /  
PAINT ALL EXPOSED SURFACES

9. STANDING SEAM METAL  
ROOFING SYSTEM / PRE-FINISHED
10. CORRUGATED "S" DECK METAL  
WALL PANEL (BARN TIN) /  
GALVANIZED FINISH
11. WOOD FASCIA TRIM / PAINT

12. STAIR AND LANDING ASSEMBLY /  
CONCRETE TREADS AND LANDINGS -  
FLAMED FINISH / 6" X 6" STEEL POST WITH  
COLLARS / EXPOSED TUBE STEEL BEAMS  
/ ALL STEEL SHALL BE PAINTED

13. GUARDRAIL / HANDRAIL ASSEMBLY /  
1" X 1 1/2" 14 GAUGE TOP RAIL / 1/2" X 1/2"  
16 GAUGE VERTICAL PICKETS AT 4" O.C. WITH  
1 1/2" X 1 1/2" 11 GAUGE HORIZONTAL RAIL /  
ALL STEEL SHALL BE PAINTED

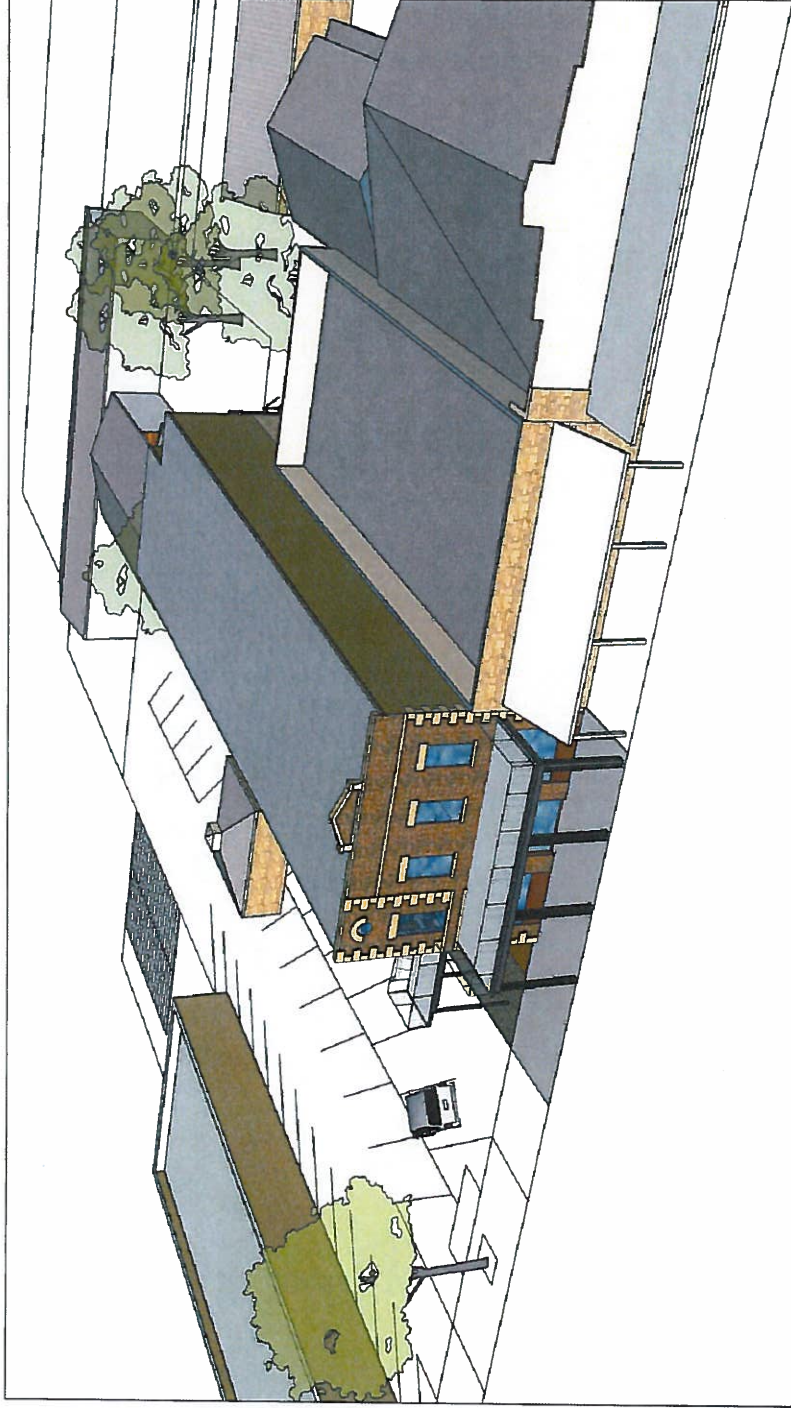
NORTHWEST VIEW OFF MAIN STREET

1. EXISTING WOOD WINDOW ASSEMBLY /  
REPLACE ALL DAMAGED GLASS PANELS /  
RECAULK ALL JOINTS / PAINT ALL WOOD  
FRAMES COMPLETE
2. EXISTING LIMESTONE TO REMAIN /  
PRESSURE WASH ALL EXPOSED SURFACES

3. EXISTING BRICK VENEER TO REMAIN /  
PRESSURE WASH ALL EXPOSED SURFACES
4. EXISTING DOOR ASSEMBLY TO REMAIN /  
PAINT ALL EXPOSED SURFACES
5. EXISTING WOOD WINDOW ASSEMBLY /  
REPLACE ALL DAMAGED GLASS PANELS /  
RECAULK ALL JOINTS / PAINT ALL WOOD  
FRAMES COMPLETE

6. EXISTING LIMESTONE TO REMAIN /  
PRESSURE WASH ALL EXPOSED SURFACES
7. EXISTING BRICK VENEER TO REMAIN /  
PRESSURE WASH ALL EXPOSED SURFACES
8. EXISTING DOOR ASSEMBLY TO REMAIN /  
PAINT ALL EXPOSED SURFACES

9. STANDING SEAM METAL  
ROOFING SYSTEM / PRE-FINISHED
10. CORRUGATED "S" DECK METAL  
WALL PANEL (BARN TIN) /  
GALVANIZED FINISH
11. WOOD FASCIA TRIM / PAINT

12. STAIR AND LANDING ASSEMBLY /  
CONCRETE TREADS AND LANDINGS -  
FLAMED FINISH / 6" X 6" STEEL POST WITH  
COLLARS / EXPOSED TUBE STEEL BEAMS  
/ ALL STEEL SHALL BE PAINTED

13. GUARDRAIL / HANDRAIL ASSEMBLY /  
1" X 1 1/2" 14 GAUGE TOP RAIL / 1/2" X 1/2"  
16 GAUGE VERTICAL PICKETS AT 4" O.C. WITH  
1 1/2" X 1 1/2" 11 GAUGE HORIZONTAL RAIL /  
ALL STEEL SHALL BE PAINTED

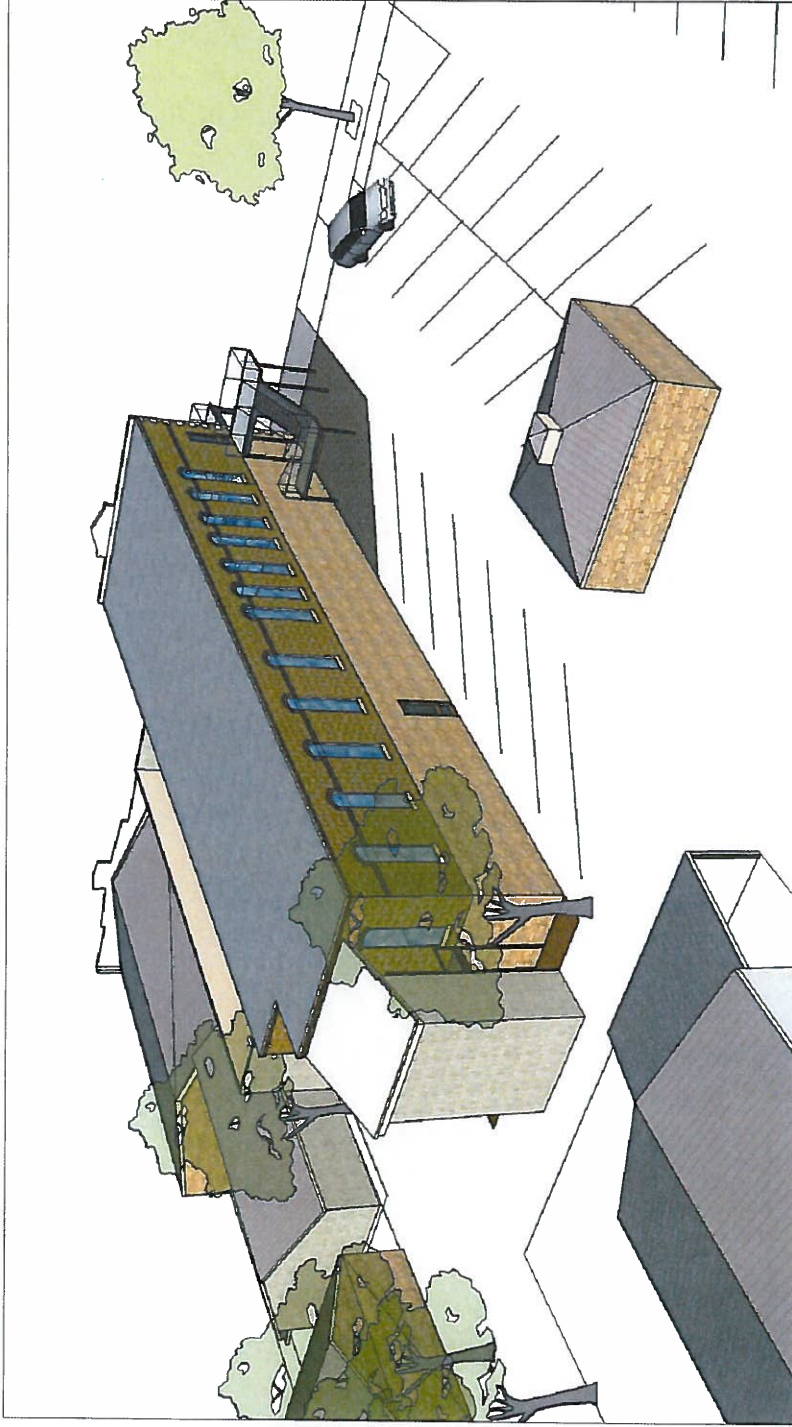
NORTH EAST VIEW

1. EXISTING WOOD WINDOW ASSEMBLY /  
REPLACE ALL DAMAGED GLASS PANELS /  
RECAULK ALL JOINTS / PAINT ALL WOOD  
FRAMES COMPLETE
2. EXISTING LIMESTONE TO REMAIN /  
PRESSURE WASH ALL EXPOSED SURFACES

3. EXISTING BRICK VENEER TO REMAIN /  
PRESSURE WASH ALL EXPOSED SURFACES
4. EXISTING DOOR ASSEMBLY TO REMAIN /  
PAINT ALL EXPOSED SURFACES
5. EXISTING WOOD WINDOW ASSEMBLY /  
REPLACE ALL DAMAGED GLASS PANELS /  
RECAULK ALL JOINTS / PAINT ALL WOOD  
FRAMES COMPLETE

6. EXISTING LIMESTONE TO REMAIN /  
PRESSURE WASH ALL EXPOSED SURFACES
7. EXISTING BRICK VENEER TO REMAIN /  
PRESSURE WASH ALL EXPOSED SURFACES
8. EXISTING DOOR ASSEMBLY TO REMAIN /  
PAINT ALL EXPOSED SURFACES

9. STANDING SEAM METAL  
ROOFING SYSTEM / PRE-FINISHED
10. CORRUGATED "S" DECK METAL  
WALL PANEL (BARN TIN) /  
GALVANIZED FINISH
11. WOOD FASCIA TRIM / PAINT

12. STAIR AND LANDING ASSEMBLY /  
CONCRETE TREADS AND LANDINGS -  
FLAMED FINISH / 6" X 6" STEEL POST WITH  
COLLARS / EXPOSED TUBE STEEL BEAMS  
/ ALL STEEL SHALL BE PAINTED

13. GUARDRAIL / HANDRAIL ASSEMBLY /  
1" X 1 1/2" 14 GAUGE TOP RAIL / 1/2" X 1/2"  
16 GAUGE VERTICAL PICKETS AT 4" O.C. WITH  
1 1/2" X 1 1/2" 11 GAUGE HORIZONTAL RAIL /  
ALL STEEL SHALL BE PAINTED
